TO: Jim Well, Ducks Unlimited  
FROM: Dai Thomas, PhD., PE, and Mike Harvey, PhD., PG  
SUBJECT: **June 2017 Resurvey of M&T/Llano Seco Pumping Plant and City of Chico Outfall Reach of the Sacramento River  
M&T/Llano Seco Fish Screen Facility Long-term Protection Project, Phase IV, Project No. US-CA-62-6**  
DATE: July 26, 2017

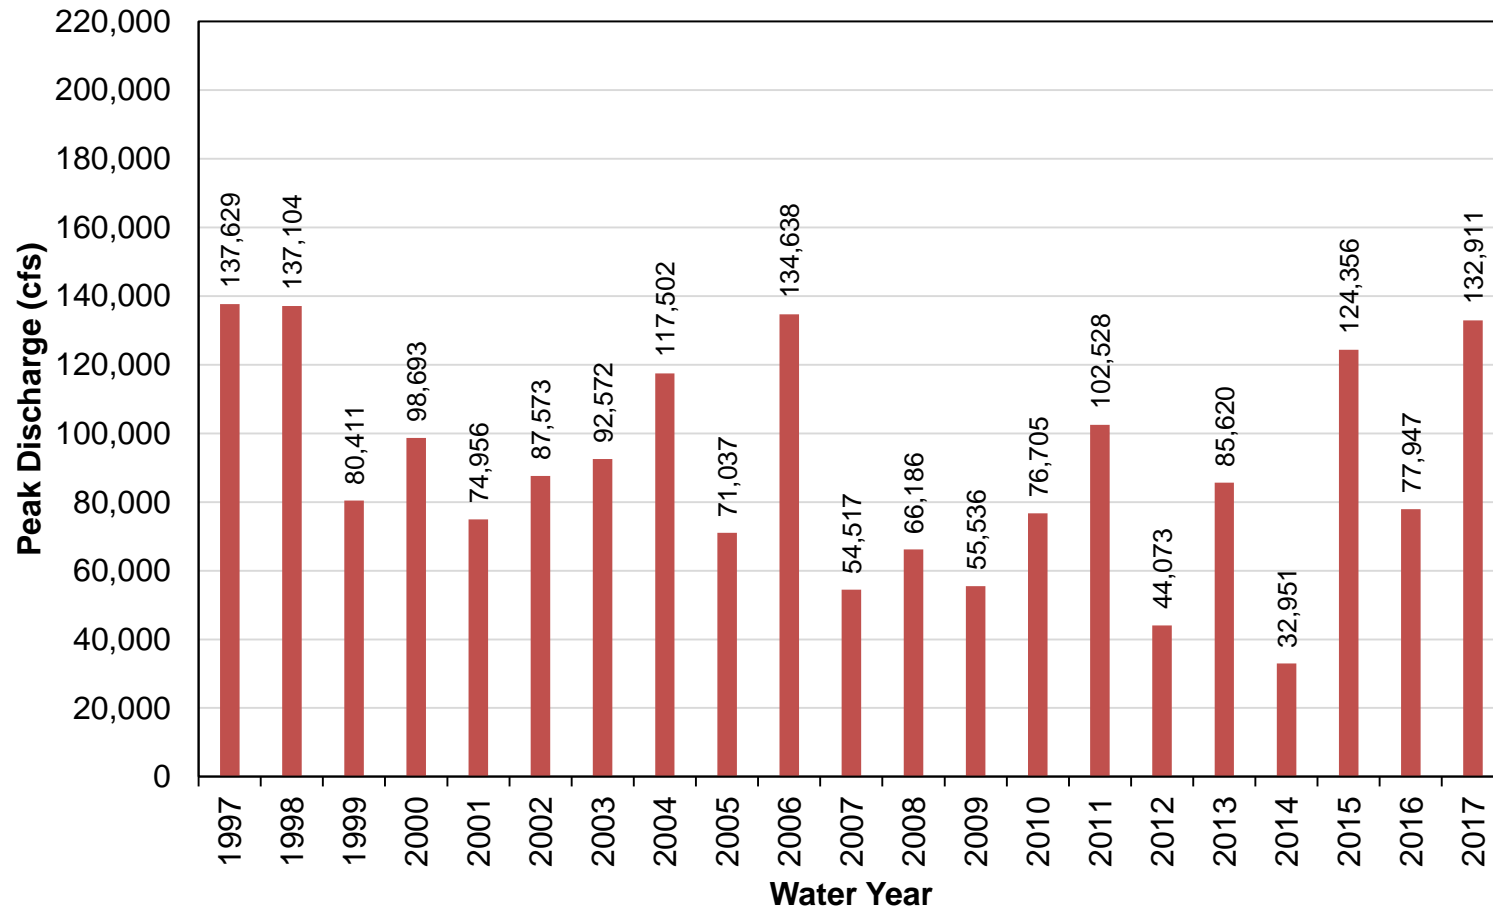
In WY2017, there were four flood events that exceeded the bankfull discharge. The fourth high flow event was the largest with a peak flow of approximately 132,900 cfs, on February 19, 2017. During this event, the flow was greater than 80,000 cfs for approximately 23 days. The peak flow of 132,900 cfs was used as the provisional peak flow event for WY2017 (**Figure 1**).

Figure 1. Peak annual flows at the Hamilton City gage between WY1997 and WY2017.

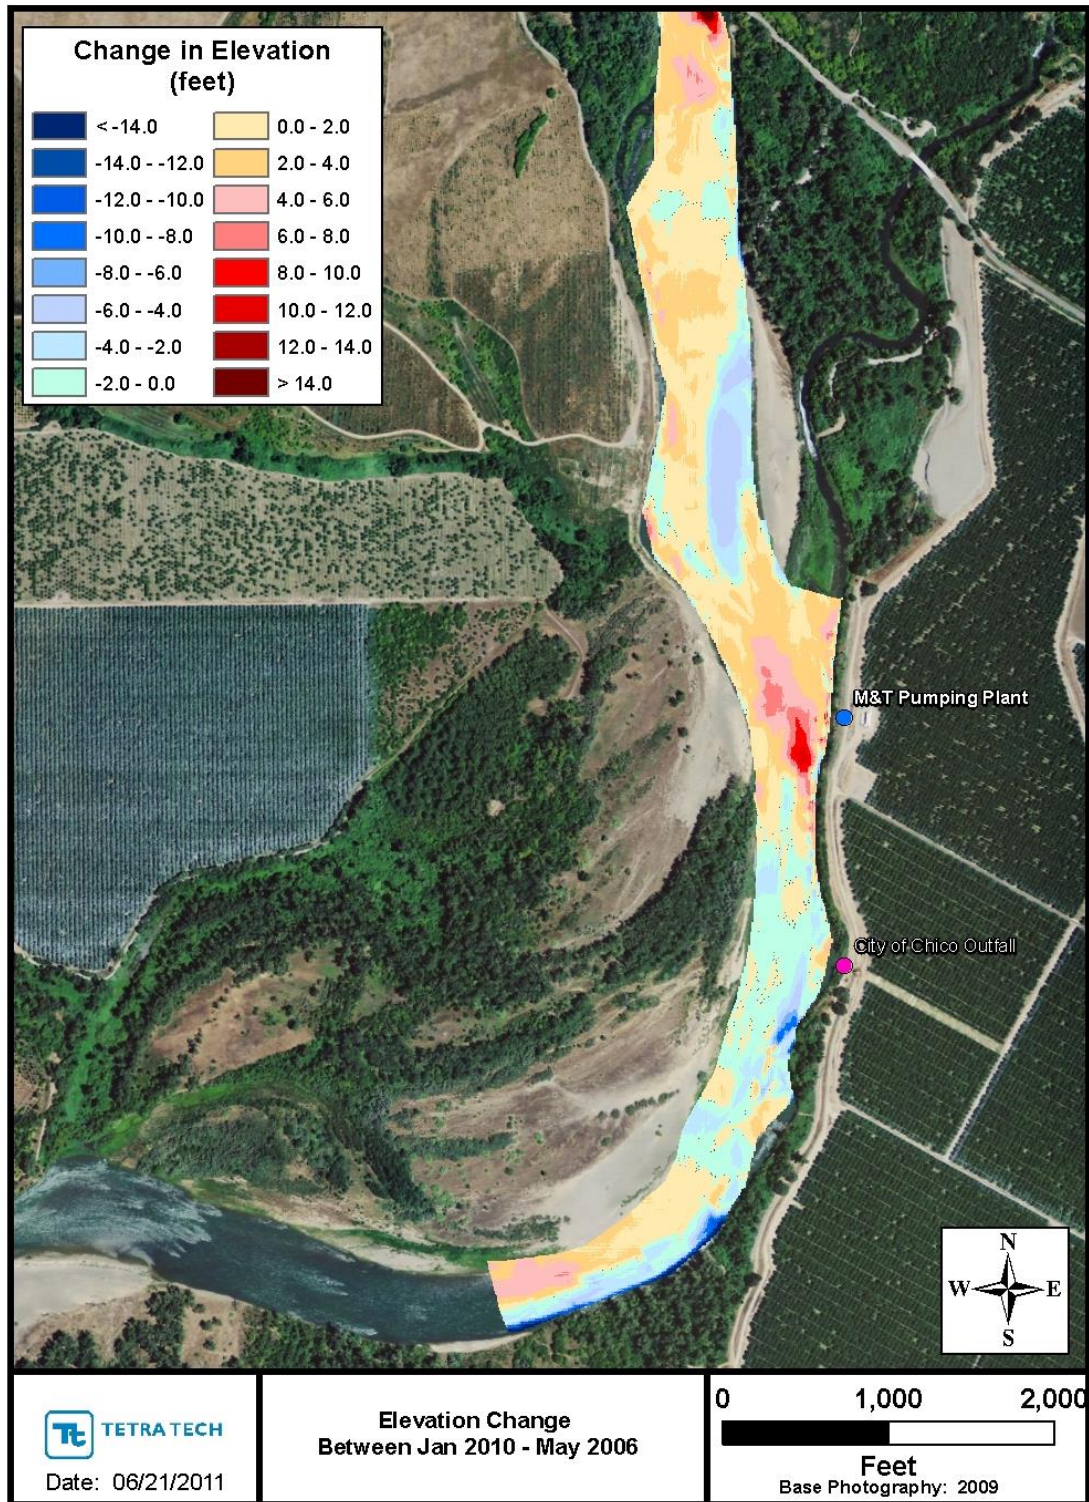
**Figure 3** presents the changes in elevation of the bed of the river within the M&T/Llano Seco reach between the 2010 and 2006 surveys. The comparison indicates that there had been significant aggradation (4 to 10 feet) in the vicinity of the pumps which was supported by observations of the river under low-flow conditions. The location of the 2007 gravel removal is clearly visible (-4 to -6 feet) along the left (east) bank of the river upstream of the pumping plant and adjacent to Bidwell State Park. **Figure 4** presents the changes in bed elevation between the 2011 survey and the 2006 survey. It is apparent that the amount of deposition in the vicinity of the pumping plant was reduced following the high flows in early 2011 (peak flow at Hamilton City was about 102,500 cfs), but there is still some aggradation when compared to the 2006 survey. **Figure 5** presents the differences in elevation of the bed of the river between the 2010 and 2011 surveys.

Figure 3. Elevation changes in the M&T/Llano Seco reach between the January 2010 and May 2006 surveys.

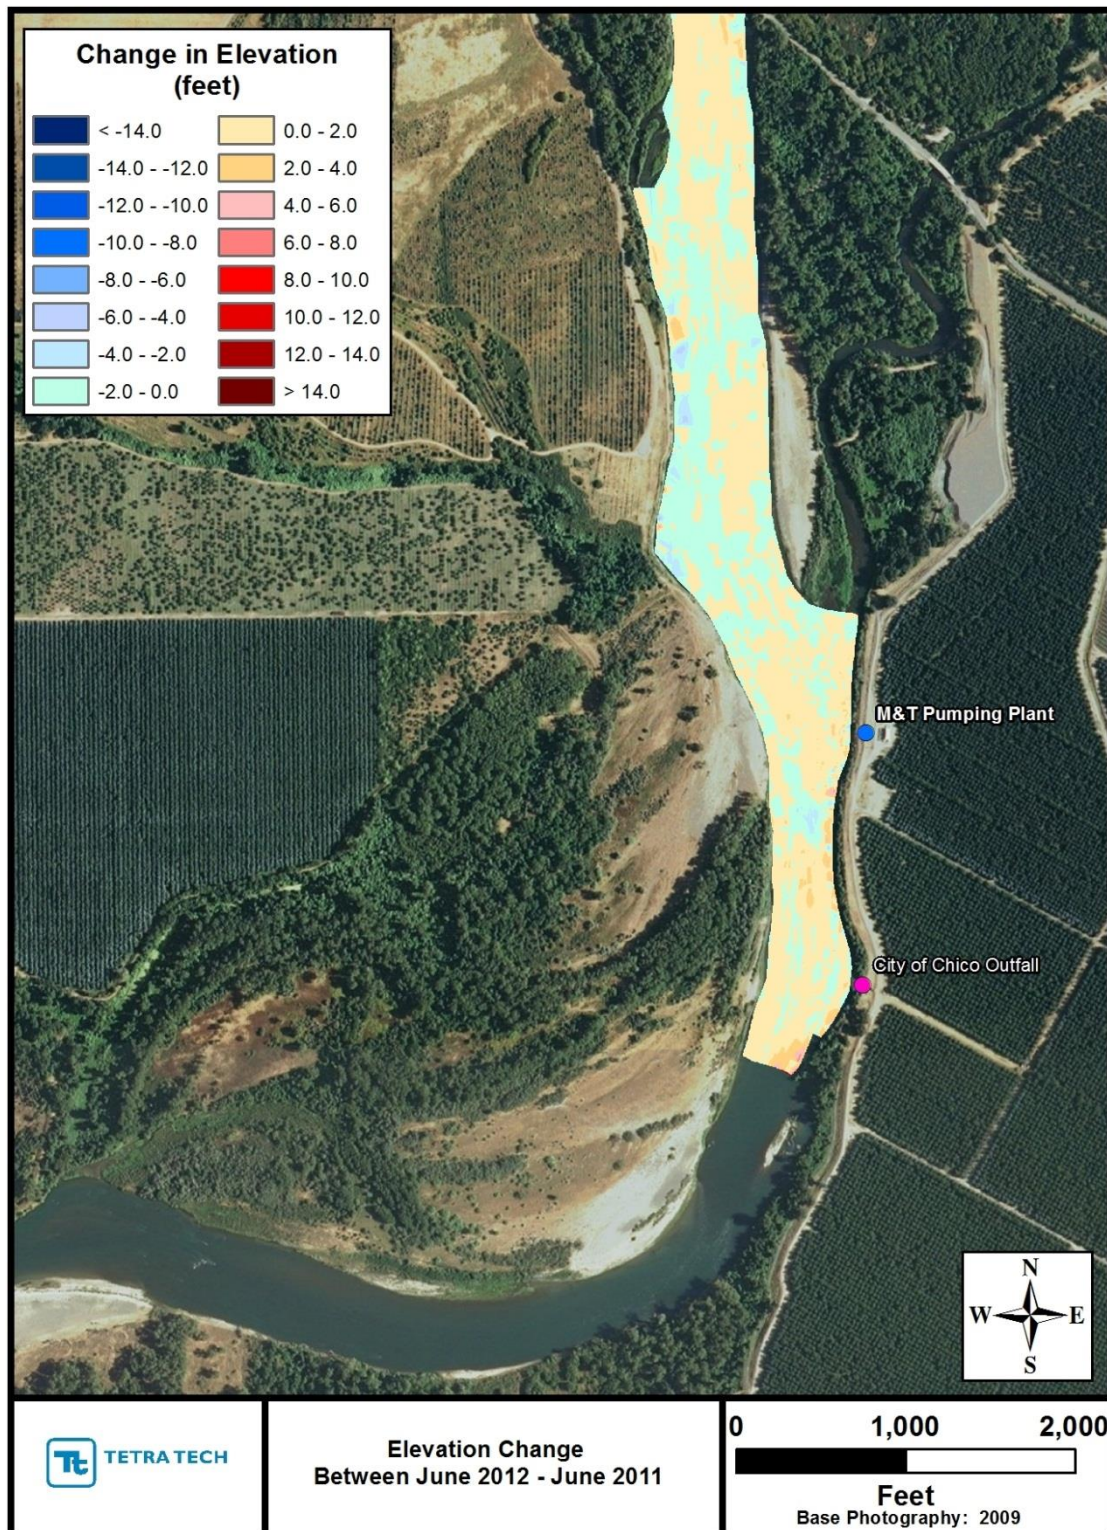
**Figure 6** presents the changes in bed elevation between the 2011 survey and the 2012 surveys. The data indicate that there was some additional aggradation in the vicinity of the pump intake as compared to the 2011 survey, which was likely due to the lack of significant peak flows during the 2012 spring runoff period (peak flow at Hamilton City was about 44,000 cfs).

Figure 6. Elevation changes in the M&T/Llano Seco reach between the June 2012 and June 2011 surveys.

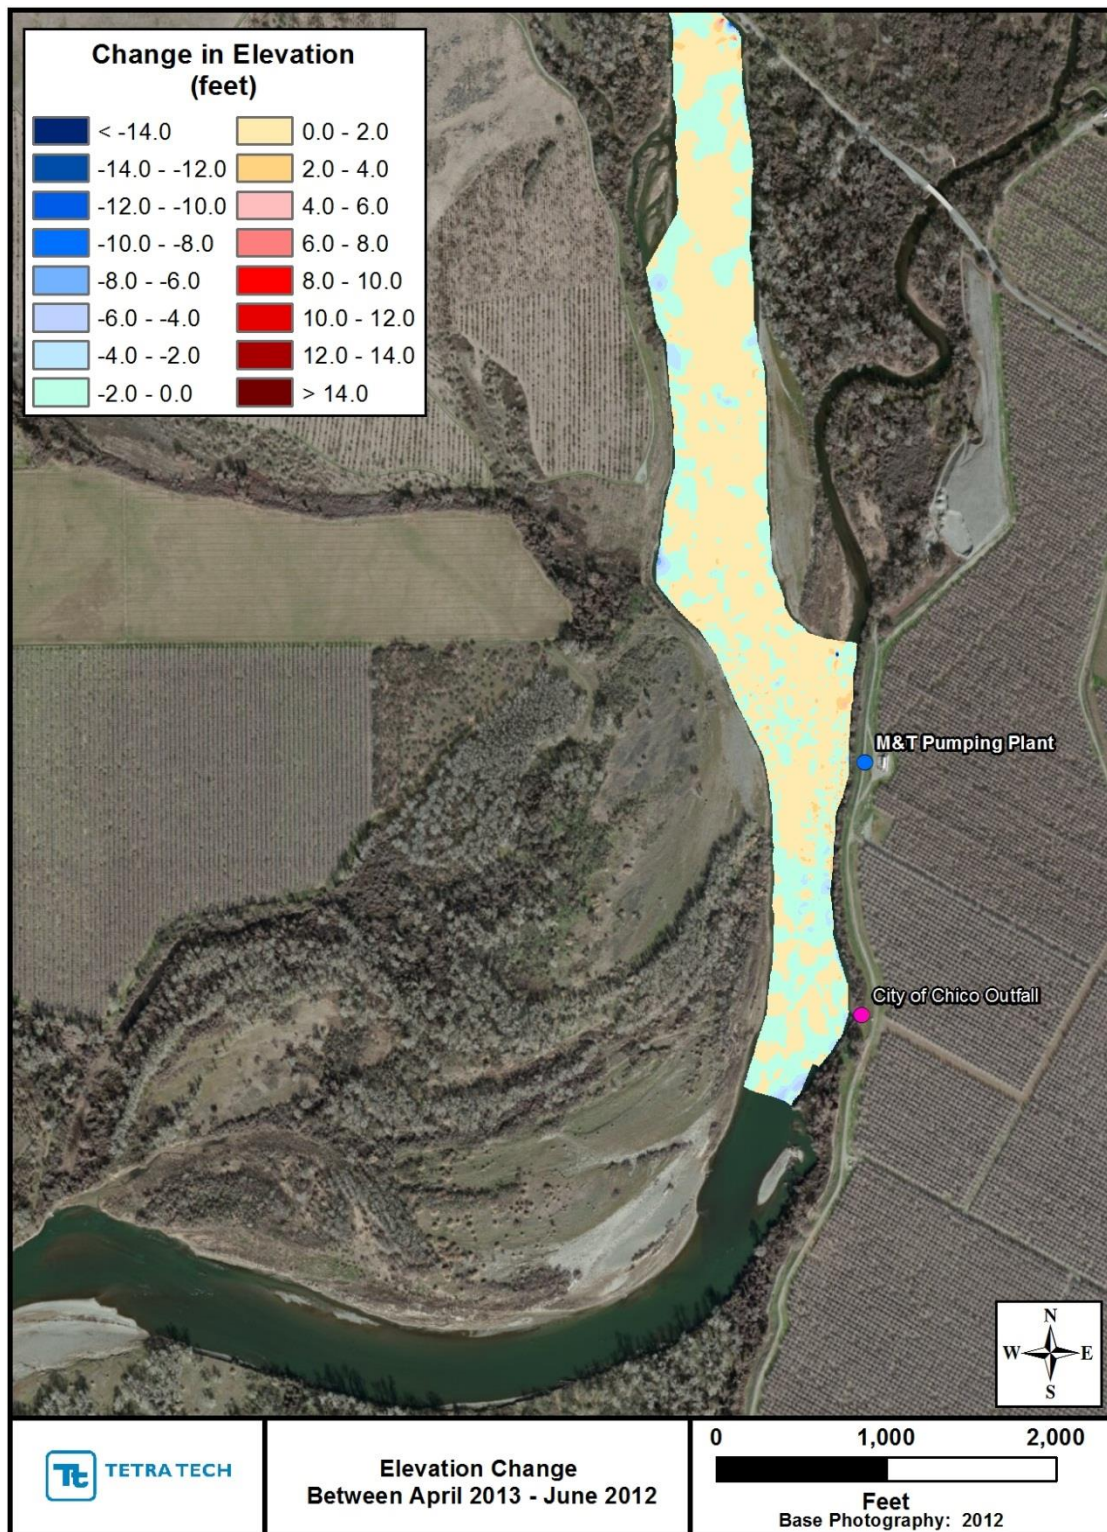
**Figure 7** presents the changes in bed elevation between the 2012 survey and the 2013 surveys. The data indicate that there was very little change in bed elevation between the 2012 and 2013 surveys with the majority of the values in the -2 to 0 or the 0- to 2-foot categories. The range of these categories has been kept consistent with the previous survey report (Tetra Tech, 2012); in general, most of the values range between -0.5 and 0.5 feet, which represents little change in bed elevation. **Figure 8** presents the differences in elevation of the bed of the river between the 2013 and 2006 surveys, and demonstrates that the site was still net aggradational.

Figure 7. Elevation changes in the M&T/Llano Seco reach between the June 2012 and May 2013 surveys.

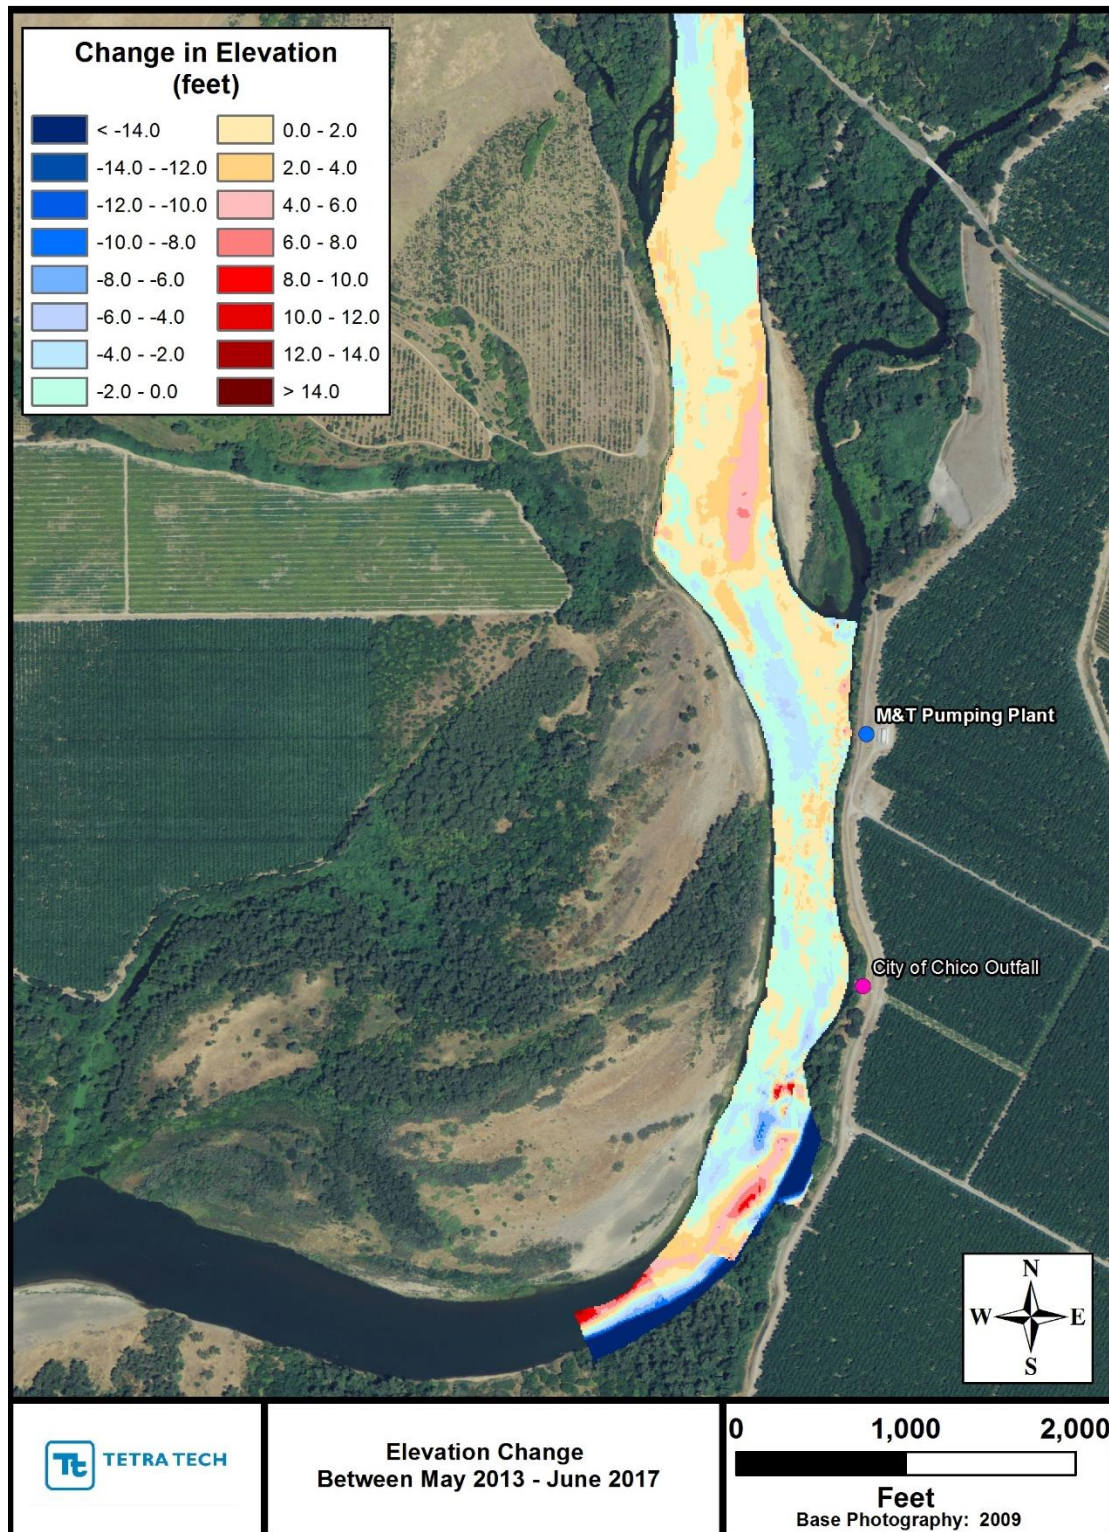
**Figure 9** presents the changes in bed elevation between the 2013 survey and the 2017 survey. There was aggradation on the order of 2 to 4 feet on the downstream end of the gravel bar, and similar amounts of aggradation were observed in the left channel of the mid-channel bar. The aggradation occurred mainly in the area that was last dredged in 2007. **Figure 10** presents the differences in elevation of the bed of the river between the 2017 and 2006 surveys, and demonstrates that the site was still net aggradational.

Between the downstream end of the gravel bar to approximately opposite the pumps, approximately 2 to 4 feet of degradation occurred near the center of the channel. Field observations and survey data collected in 2013 indicated the eroded subsurface bar was comprised of sand and fine gravel. The channel near the left bank between the pumps and Big Chico Creek aggraded by up to 4 feet.

Figure 9. Elevation changes in the M&T/Llano Seco reach between the June 2017 and May 2013 surveys.

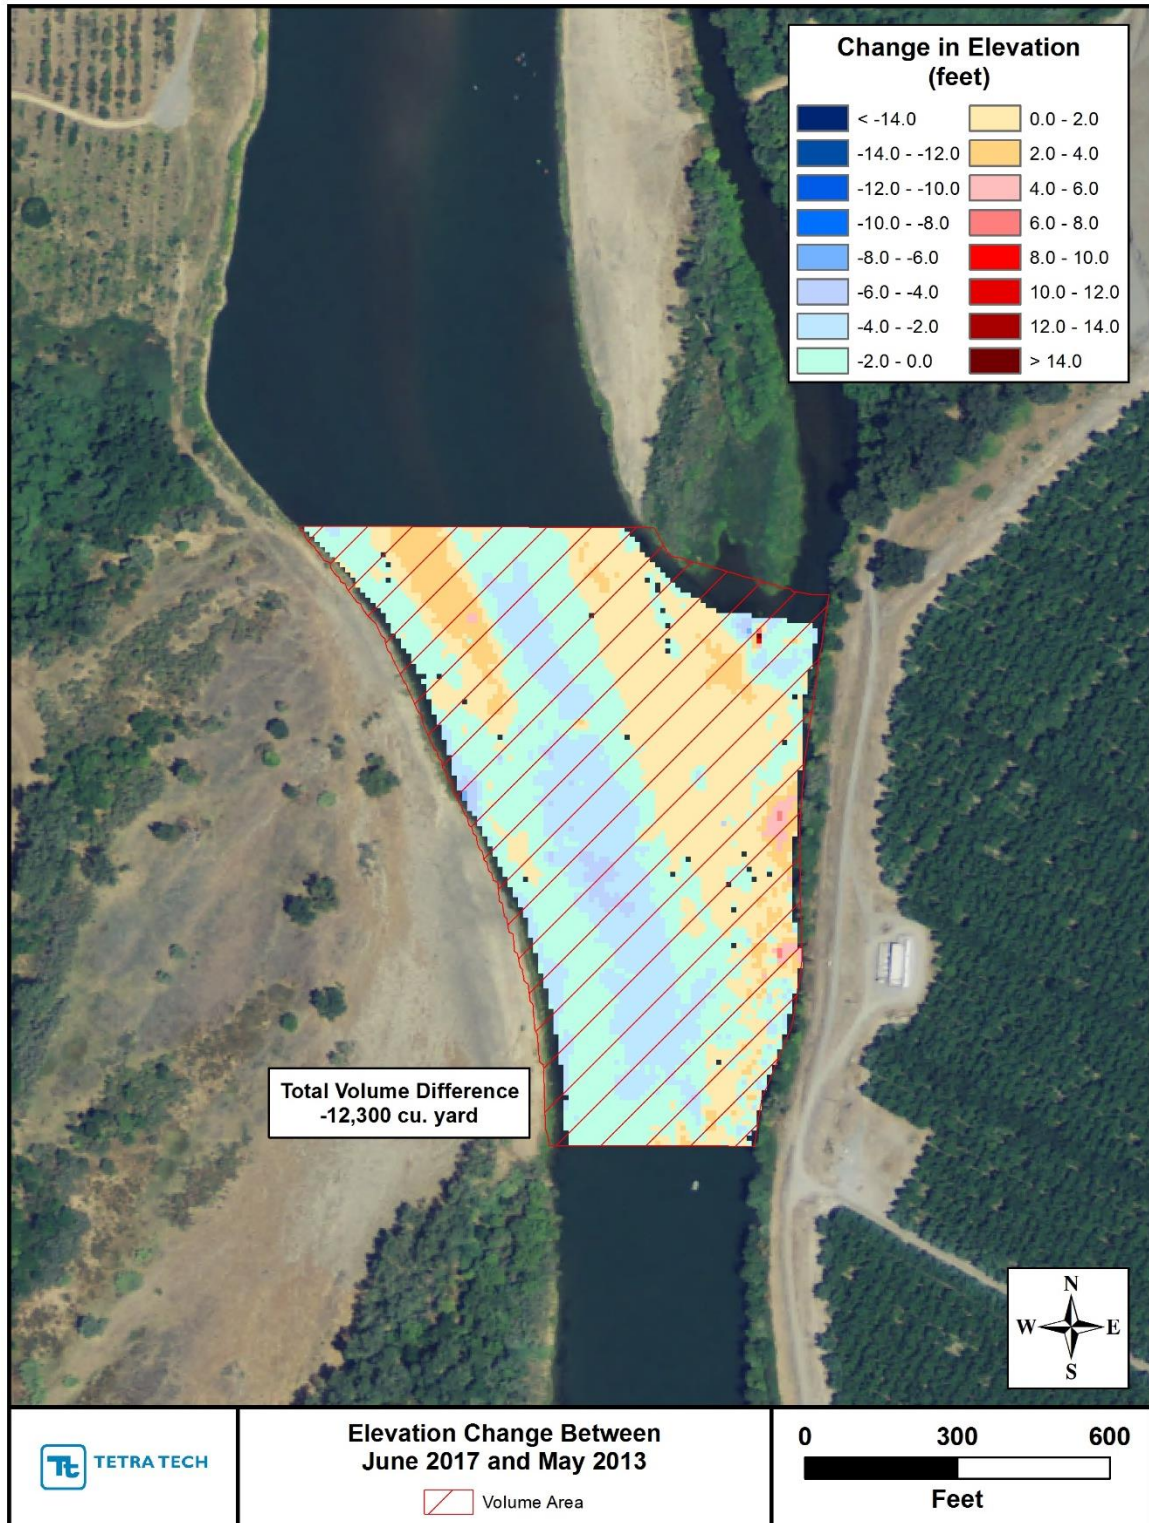
To further evaluate bed elevation changes between 2006 and 2013, and to determine the volume of dredge material in the vicinity of the fish screens and pump inlets, an approximately 600- by 1,200-foot area was designated and the difference in volume between surveys was determined. Between the 2006 and 2010 surveys, about 89,000 cu.yd. (~120,000 tons) of material accumulated (**Figure 11**). Between the 2011 and 2006 surveys, the volume of material that accumulated was reduced to about 54,400 cu.yd. (~72,900 tons) (**Figure 12**). Between 2010 and 2011, there was net loss of about 34,800 cu.yd. (~47,000 tons) of material (**Figure 13**). Between the 2012 and 2006 surveys, there was a net accumulation of about 61,300 cu.yd (~82,800 tons) (**Figure 14**). From 2011 to 2012, there was slight aggradation in the delineated area and a net gain of about 6,700 cu.yd (~9,000 tons) of material (**Figure 15**). Between the 2013 and 2006 surveys, there was a net accumulation of about 66,000 cu.yd (~89,100 tons) (**Figure 16**). From 2012 to 2013, there was slight aggradation in the delineated area and a net gain of about 3,600 cu.yd (~4,860 tons) of material (**Figure 17**). Between 2013 and 2017, there was a net loss of about 12,300 cu. yd (~16,600 tons) that was mostly due to the erosion of the downstream end of

Figure 18. Volumetric calculation of the deposition in the 600- by 1,200-foot segment in the vicinity of the fish screens and pump inlets between the June 2017 and May 2013 surveys.

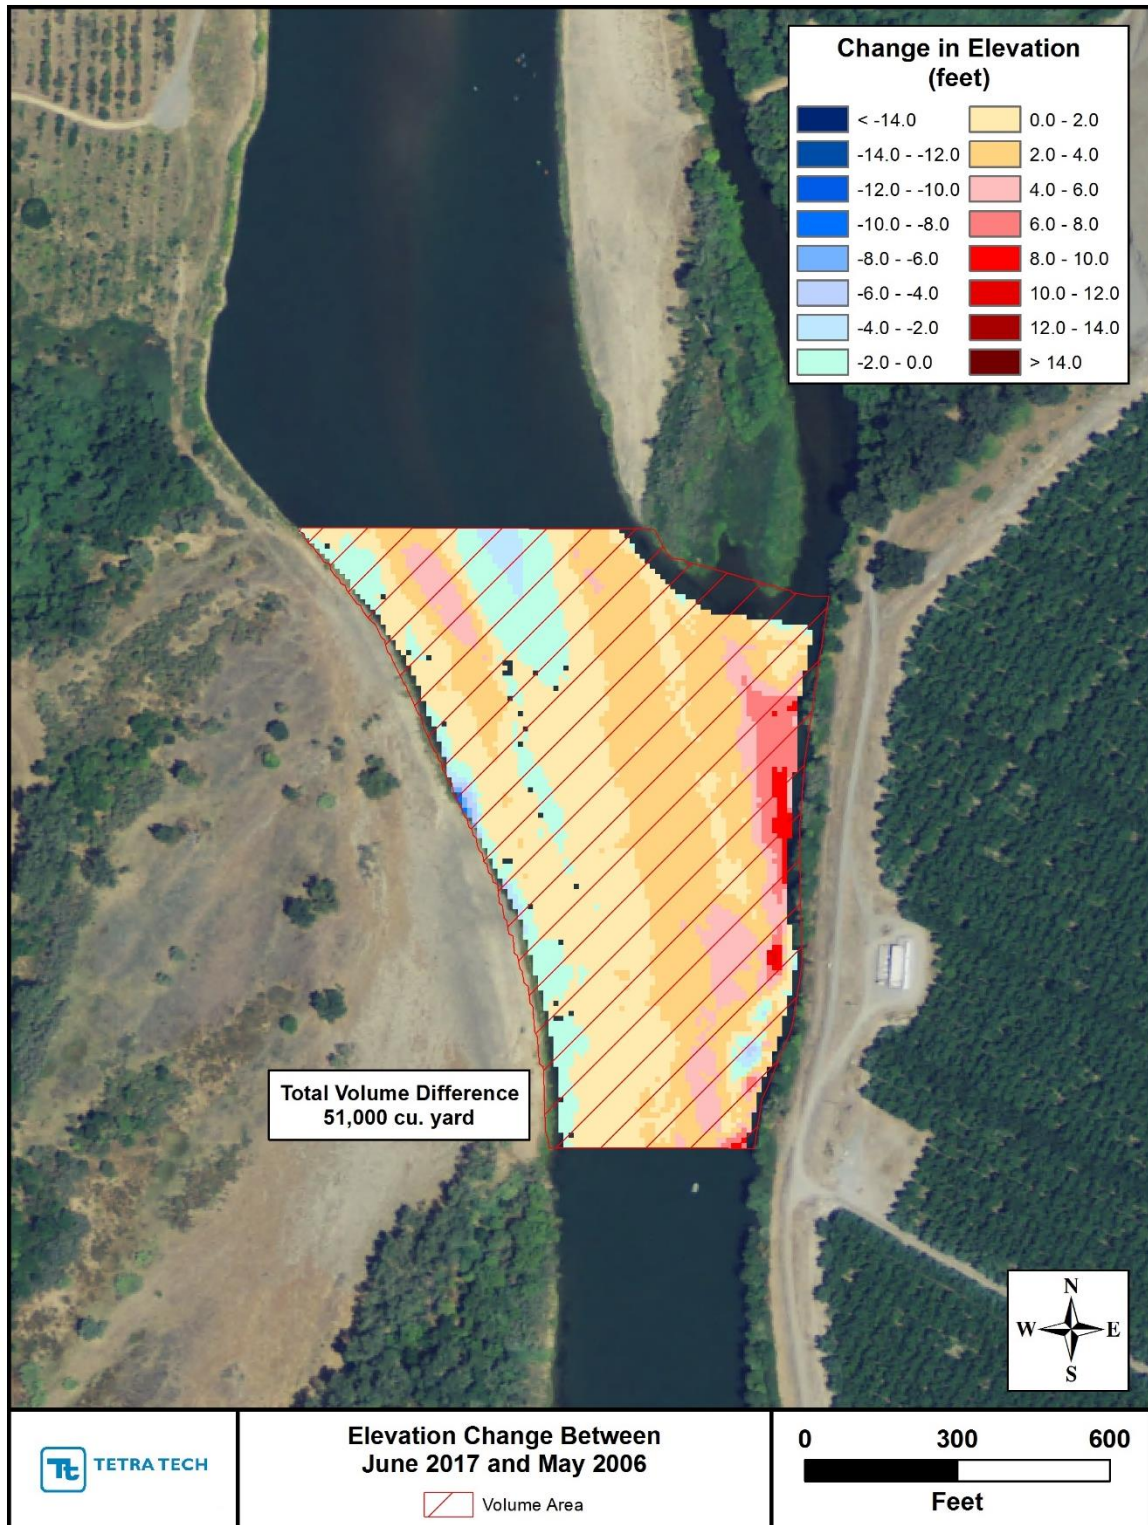
the subsurface bar (**Figure 18**). From 2006 to 2017, there has been a net gain of about 51,000 cu. yd. (~68,850 tons) (**Figure 19**).

Figure 19. Volumetric calculation of the deposition in the 600- by 1,200-foot segment in the vicinity of the fish screens and pump inlets between the June 2017 and May 2006 surveys.

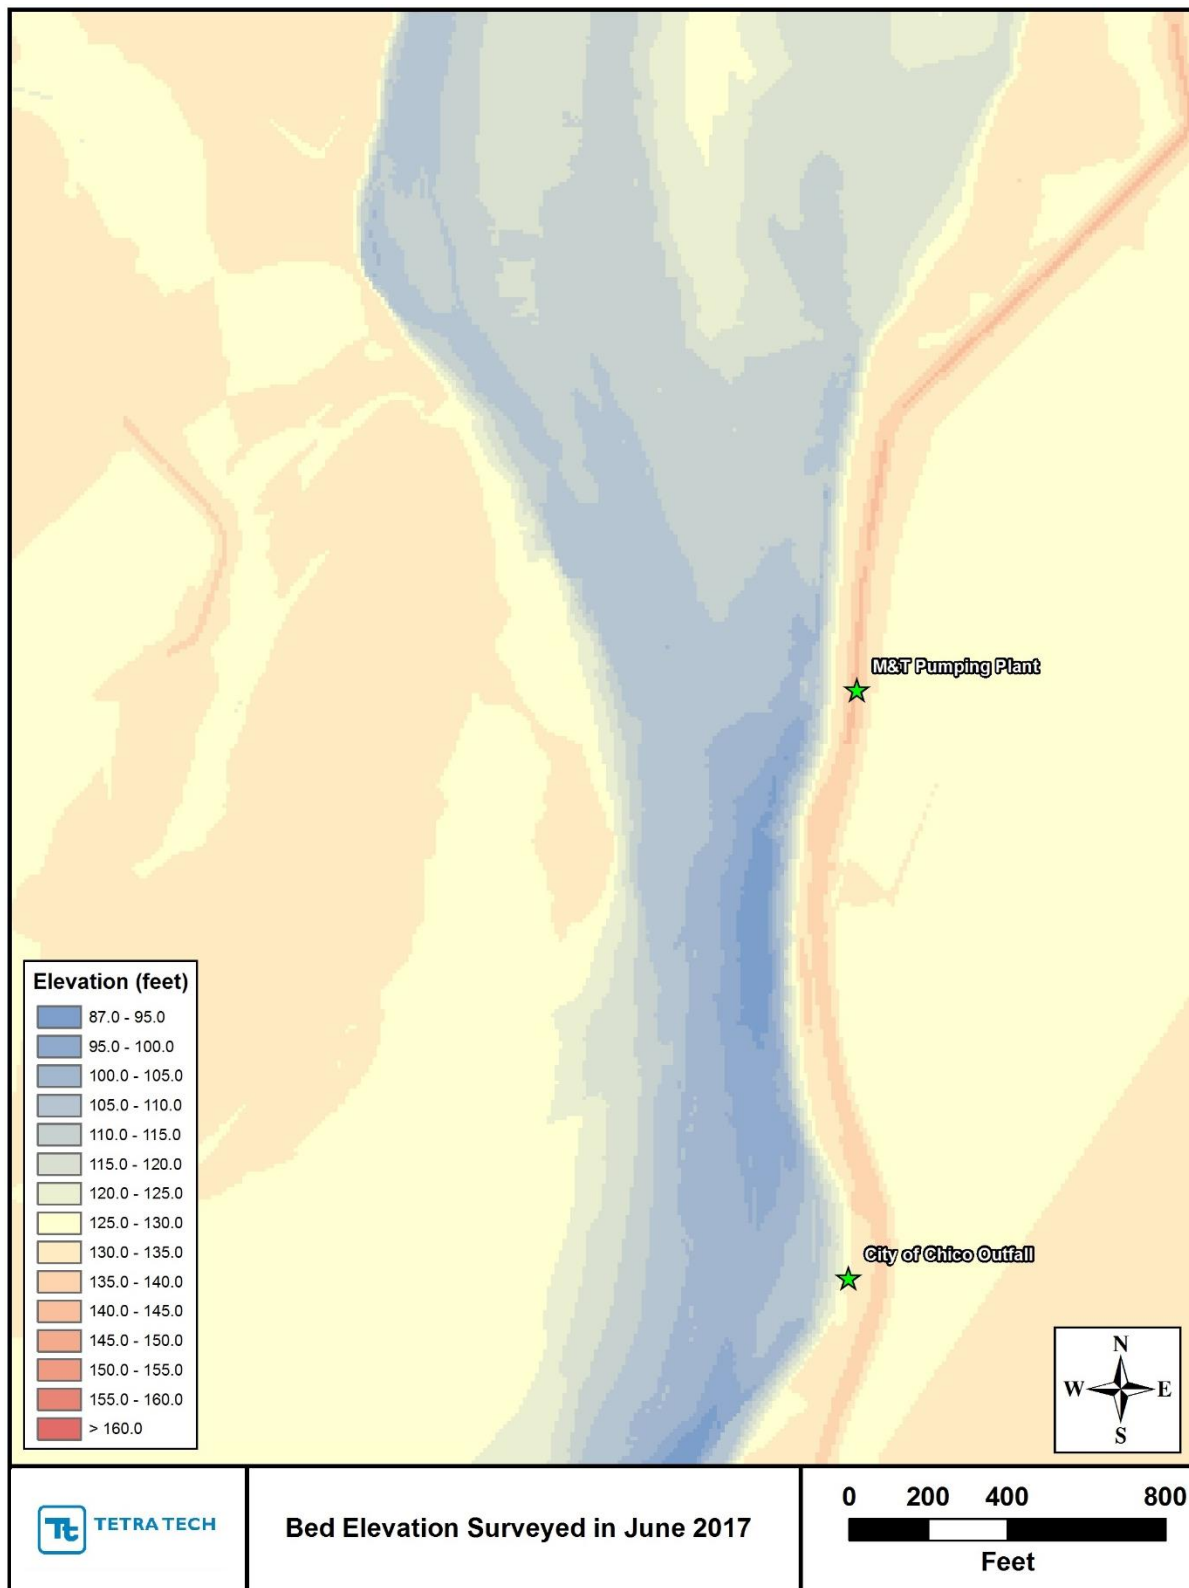
The peak flow between the 2012 and 2013 surveys was about 85,600 cfs, which is slightly less than the bankfull discharge of 90,000 cfs, and the duration of the peak flow event was less than one day. Between 2012 and 2013, there was a relatively small amount of deposition in the vicinity of the fish screens and pump inlets, but the general pattern of deposition at less than bankfull discharges was observed (Figure 17 and **Figure 24**). Between 2013 and 2017, peak flows exceeded the bankfull discharge on several occasions, but in general the period was relatively dry. There was slight degradation along and near the thalweg, and aggradation along the left bank of the channel and in the vicinity of the fish screens (Figure 19 and **Figure 25**).

Figure 25. Color gradient plot showing the bed topography in the vicinity of the M&T/Llano Seco Pumping Plant and the relocated City of Chico Outfall in June 2017.

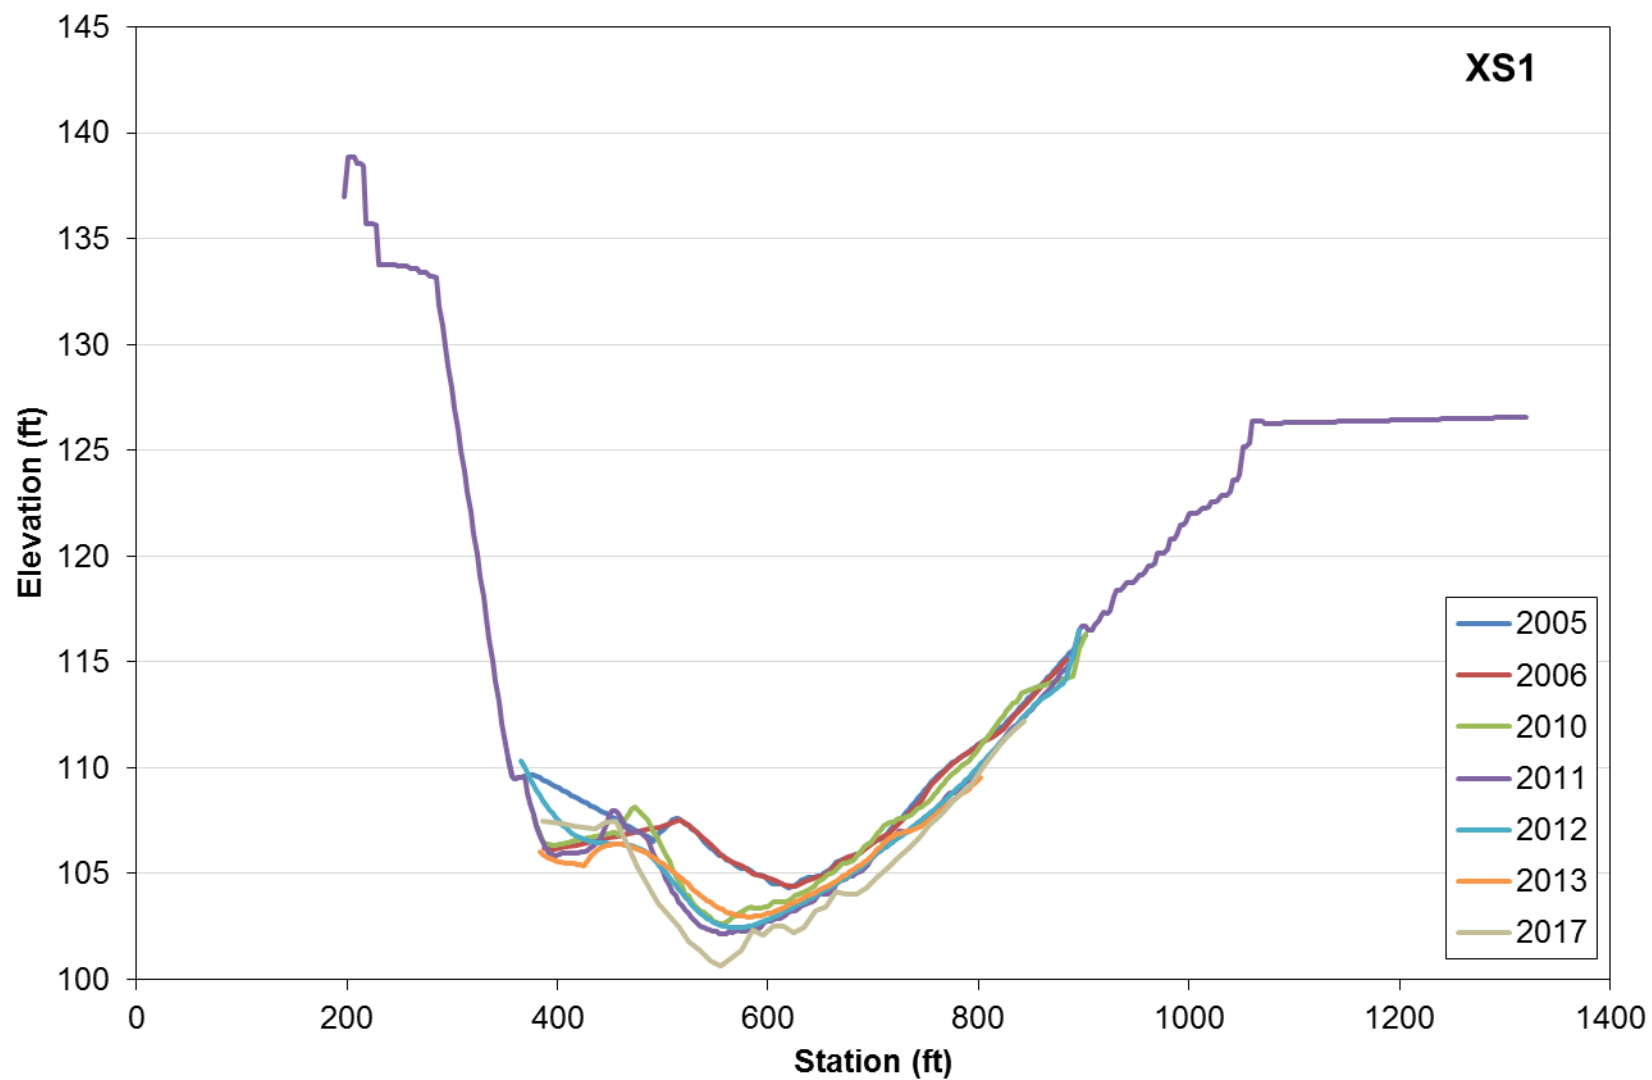
At the City of Chico's outfall (**Figure 27**), the cross sections indicate that there was some aggradation on the left (east) side of the channel in 2005 but the 2006, 2010 and 2011 surveys show that the local aggradation was removed. The 2012 survey shows a small amount of aggradation near the left bank in the vicinity of Sta 440 and degradation in the vicinity of Sta 450. The 2013 survey shows slight degradation along the left side of the channel from near the left bank (east) to approximately Station 430. The 2013 survey also shows no change from the location of the thalweg (~Sta 560) to Sta 890 compared to the 2012 survey. In the 2017 survey, aggradation was observed near the left bank of the channel, while degradation was observed from about Sta 450 to Sta 750. The thalweg appears to have migrated towards channel left by about 75 feet since 2005.

Figure 27. Comparative cross-section plots, 2005 to 2017 at the relocated City of Chico outfall.

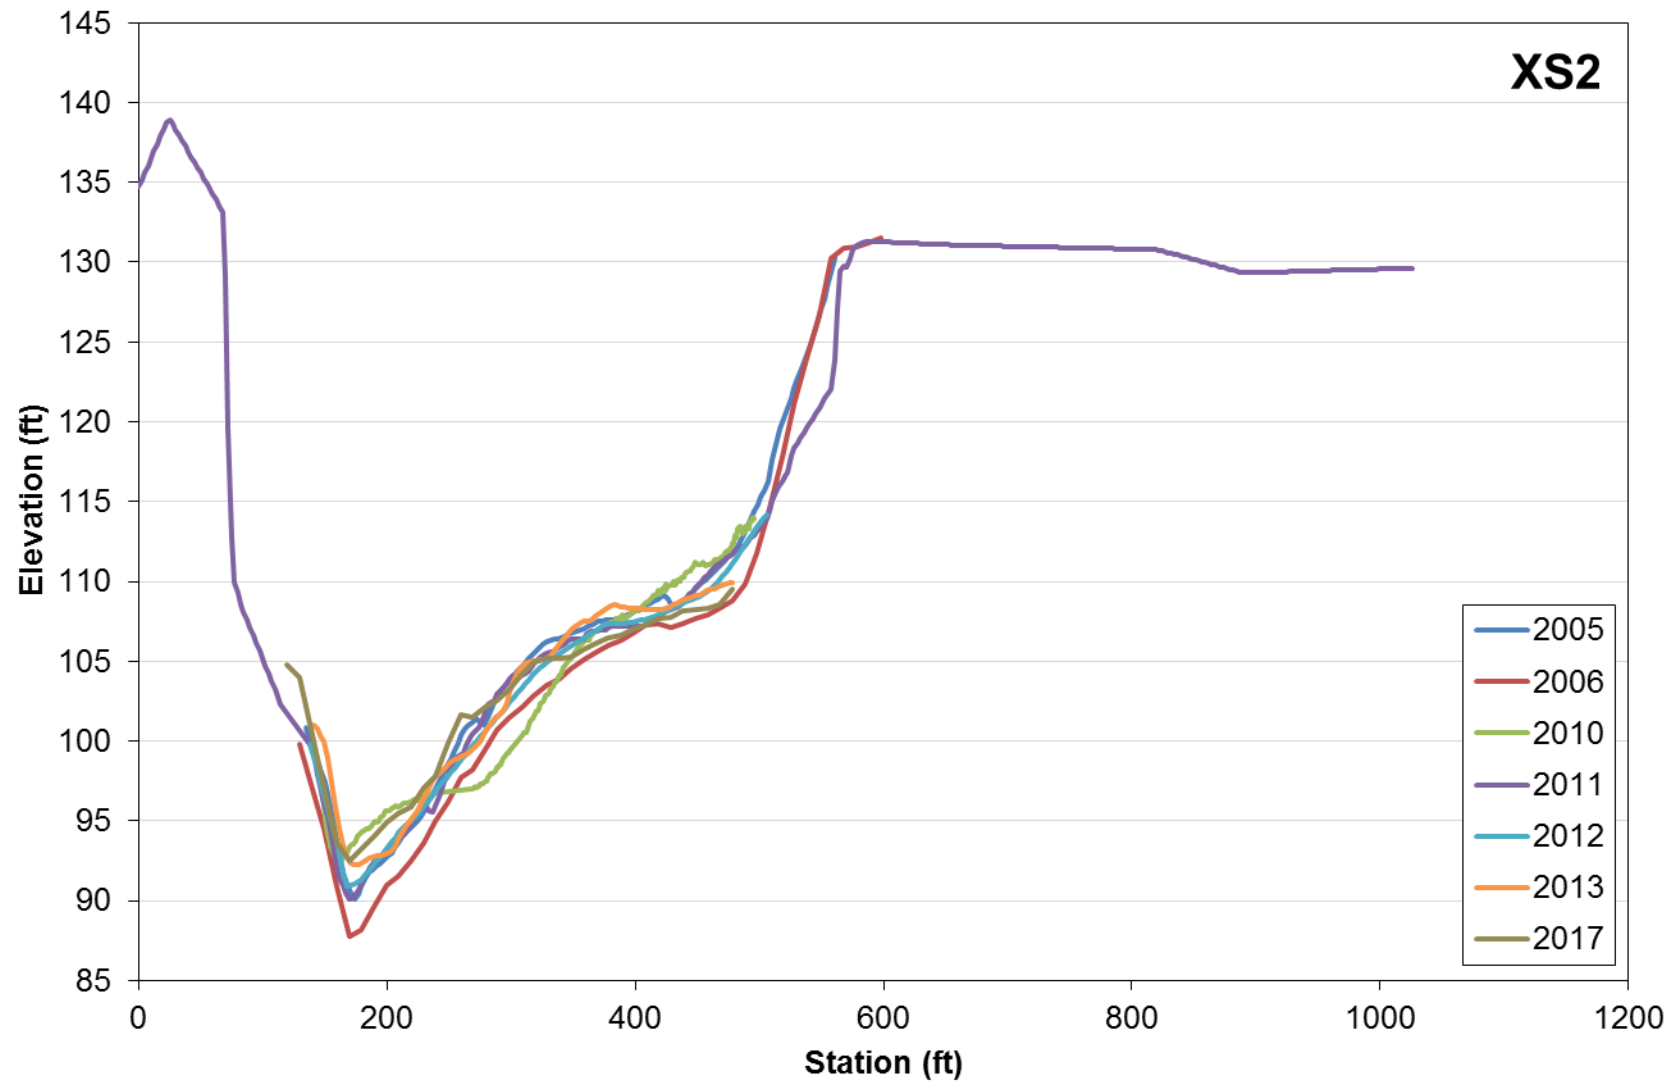
At the location of the City's former outfall (**Figure 28**), it is apparent that the aggradation in 2010 was removed by the flows in 2011 and that the depth of scour probably depends on the magnitude of the high flows since the bed elevation in 2006 is the lowest. The 2012 survey shows there was very little change along the cross section compared to 2011 conditions. The 2013 survey shows approximately 1.5 feet of degradation at the channel thalweg (~Sta 170) compared to the 2012 survey. The 2013 survey also shows slight aggradation along the right side of the channel from Sta 290 to Sta 450. Only slight changes were observed at the cross-section between 2013 and 2017.

Figure 28. Comparative cross-section plots, 2005 to 2017 at the original City of Chico outfall.
