TO: Jim Well, Ducks Unlimited  
FROM: Dai Thomas, PhD., PE, and Mike Harvey, PhD., PG  
SUBJECT: **June 2017 Resurvey of M&T/Llano Seco Pumping Plant and City of Chico Outfall Reach of the Sacramento River  
M&T/Llano Seco Fish Screen Facility Long-term Protection Project, Phase IV, Project No. US-CA-62-6**  
DATE: July 26, 2017

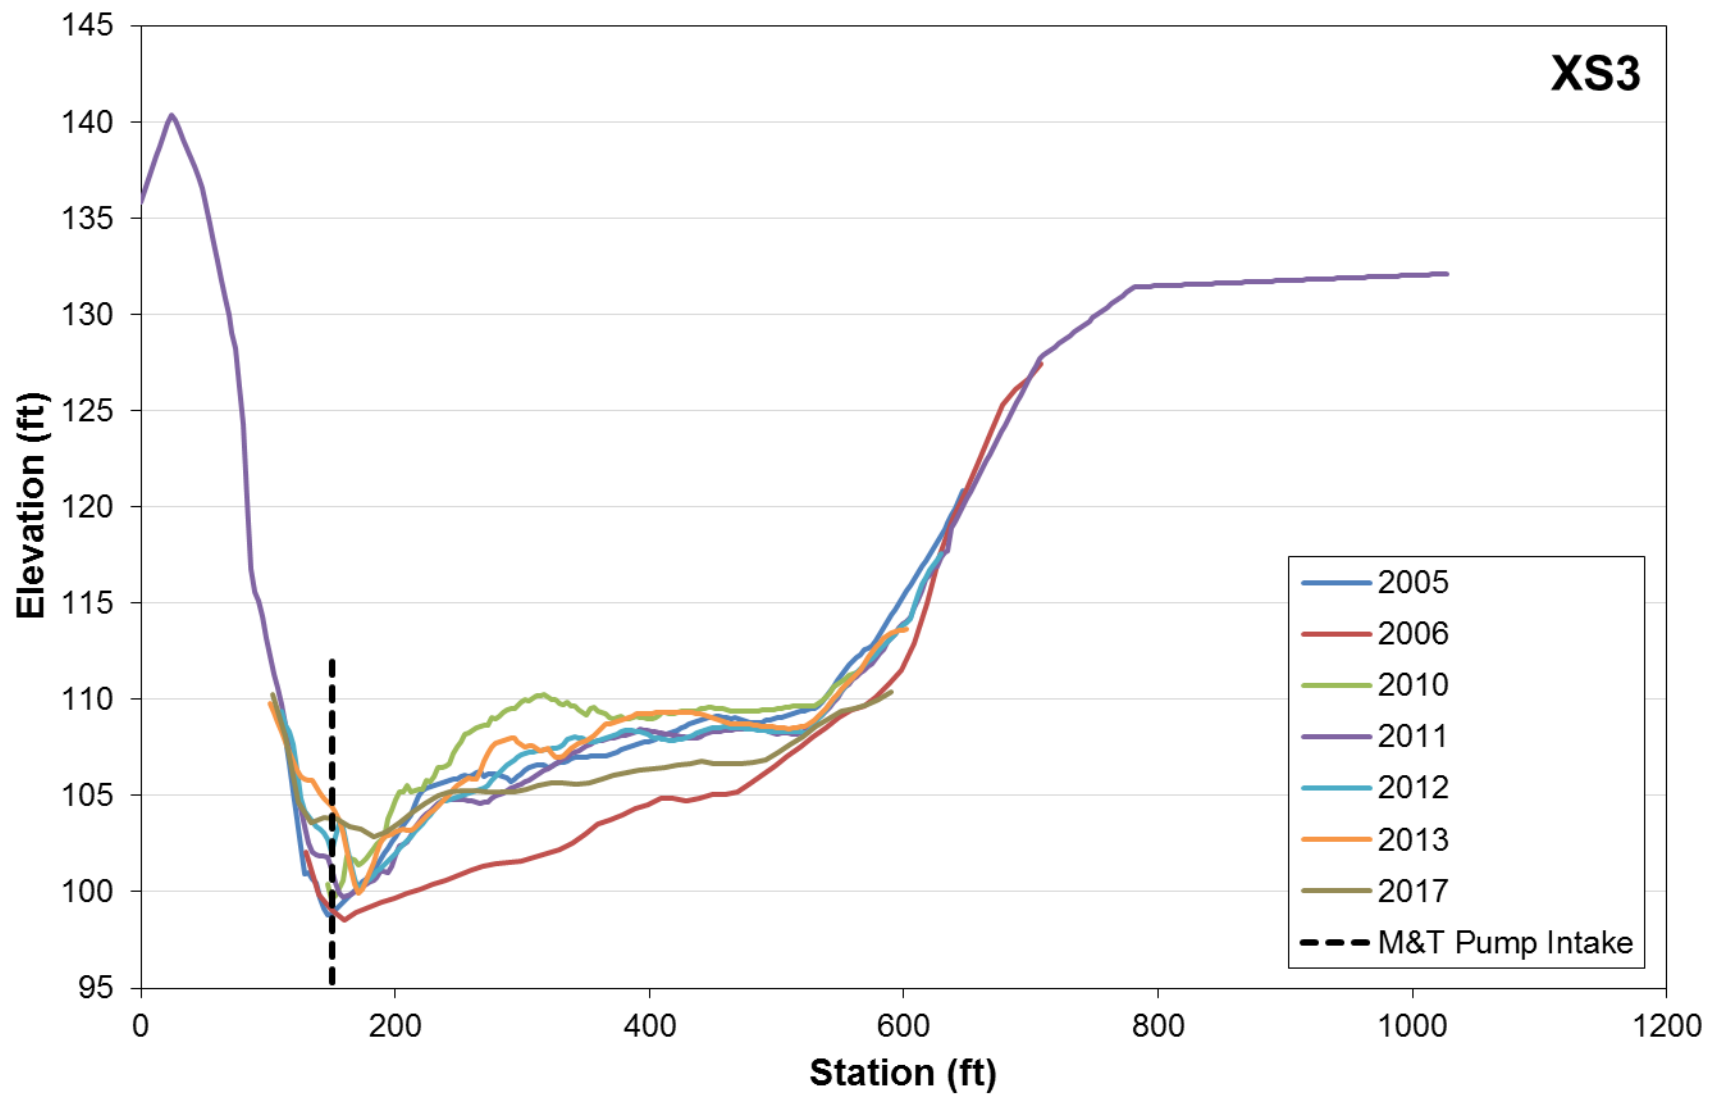
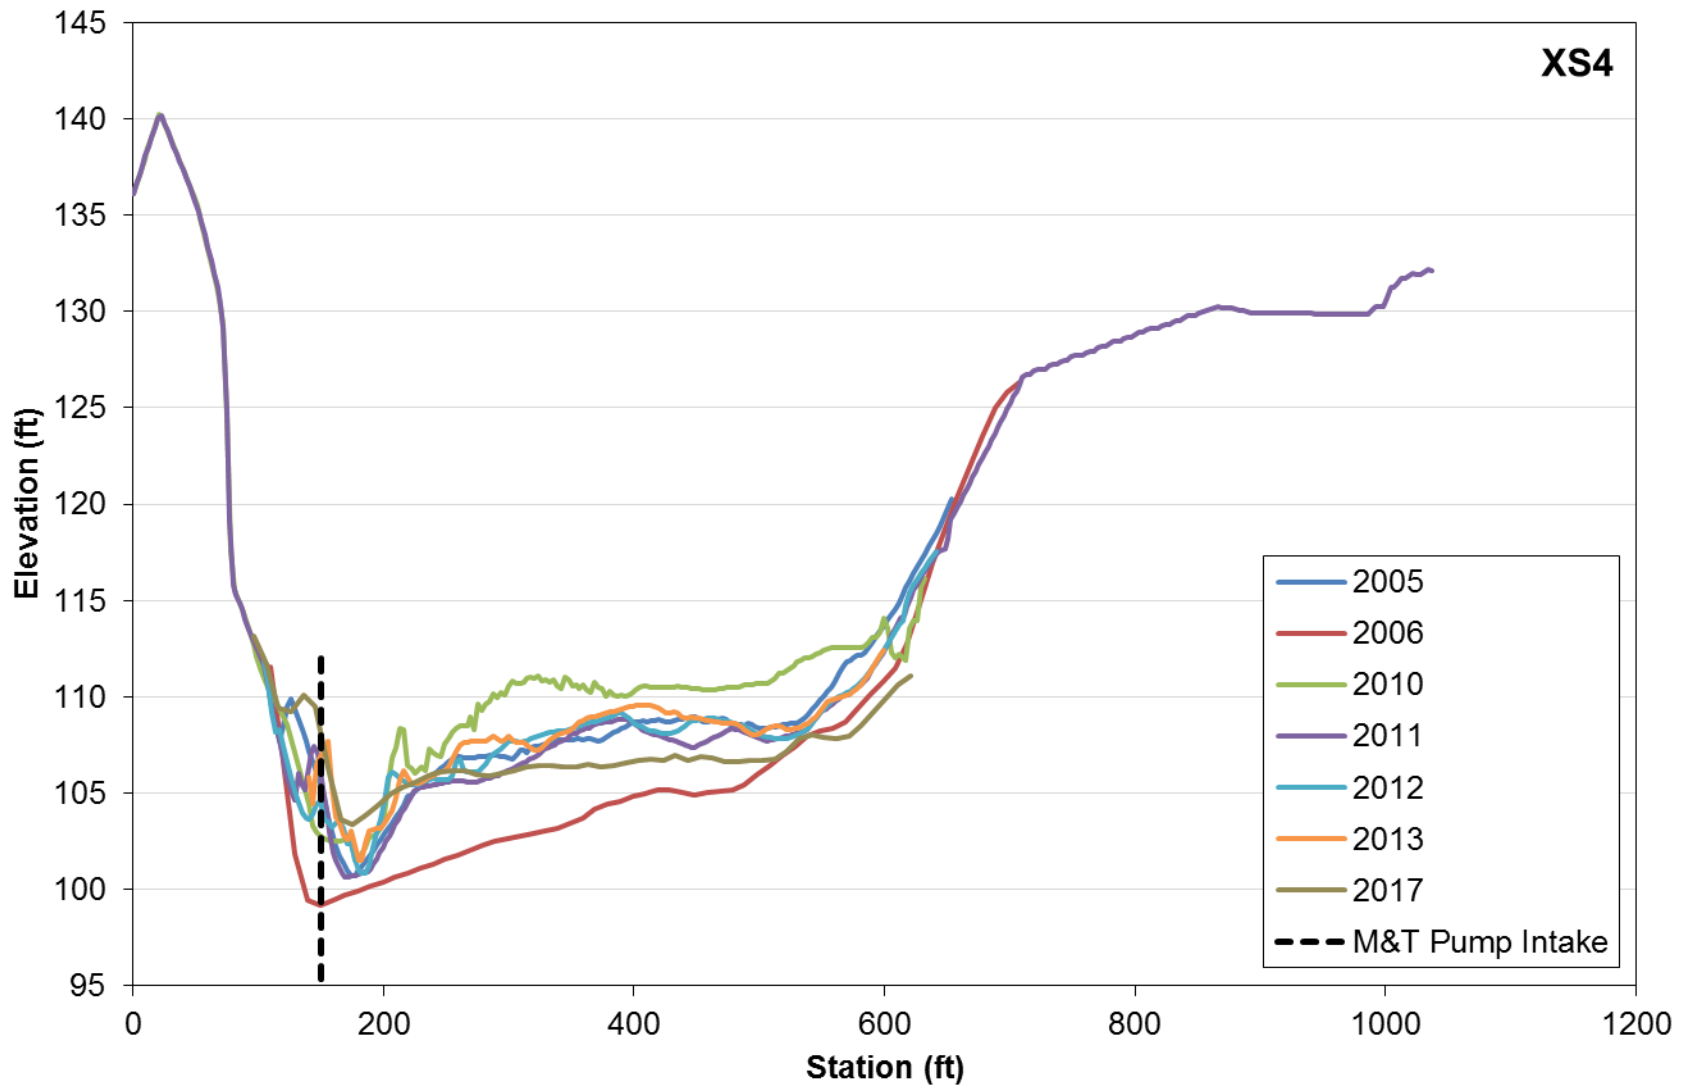
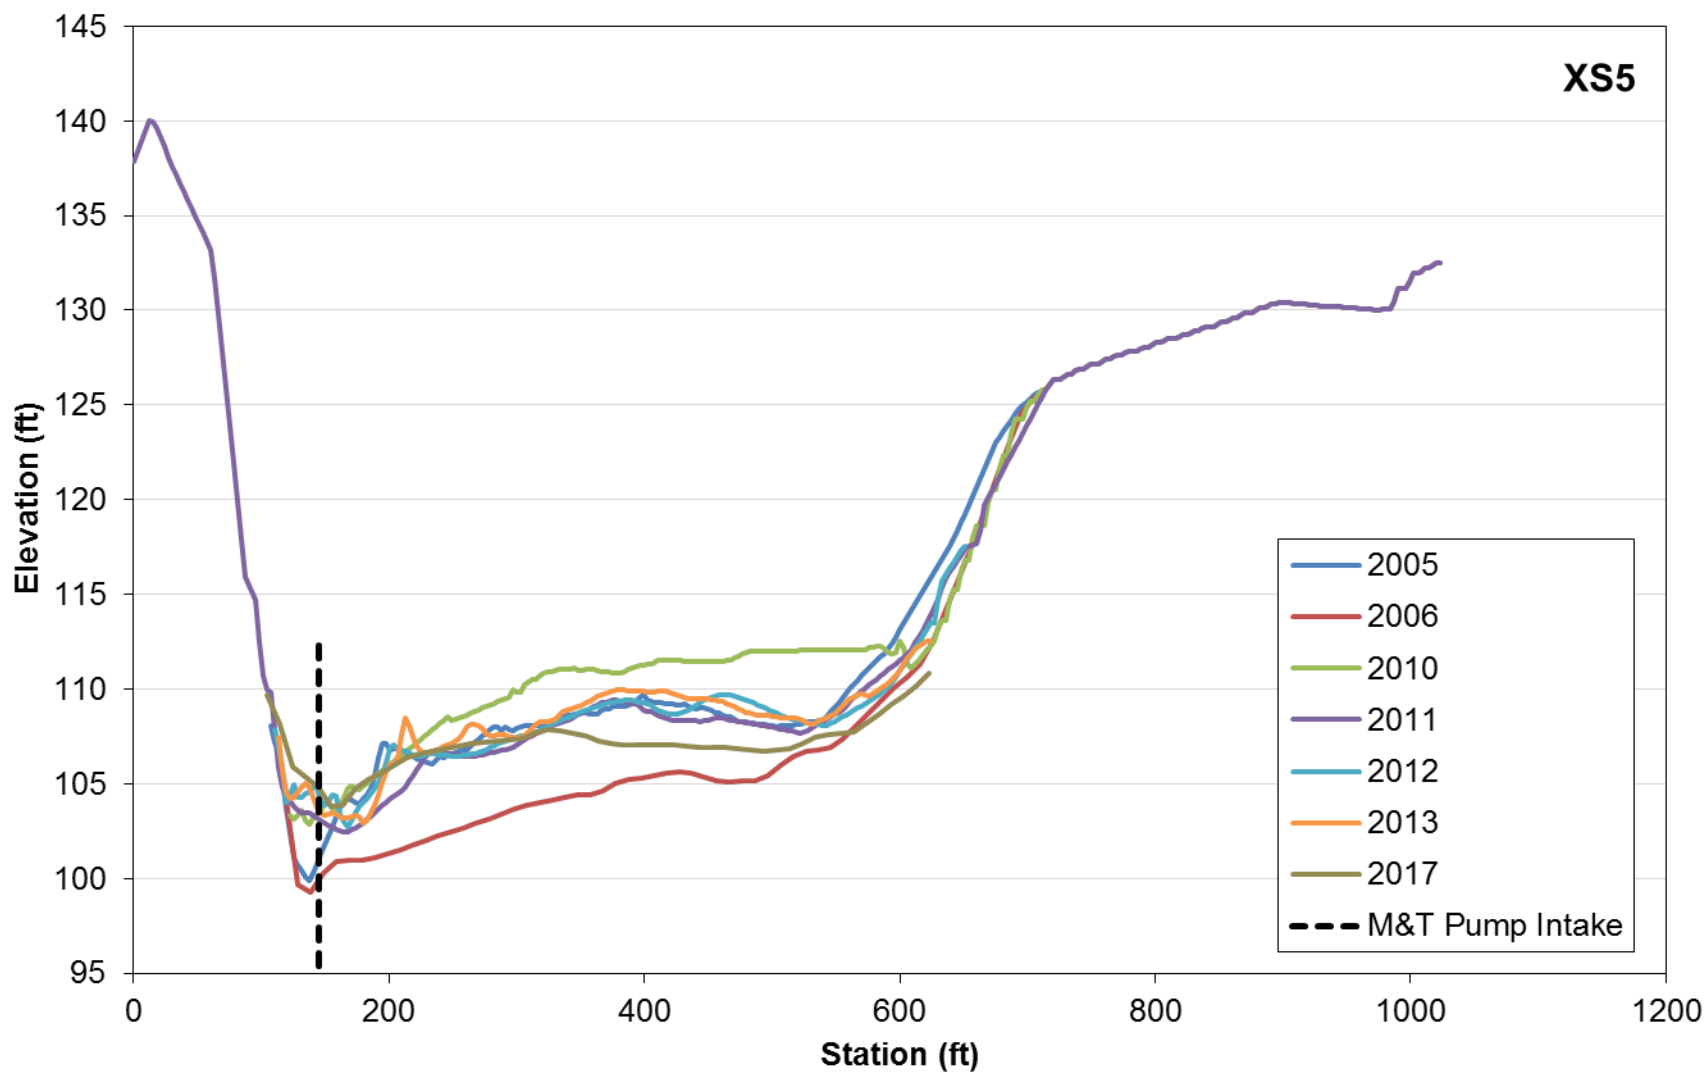
At the location of the fish screens and pump inlets (**Figures 29 through 31**) it is clear that during the lower peak flow years the deposition approaches the inlets and fish screens, and it is eroded during the higher-flow years. At XS3 (located slightly downstream from the fish screen), the 2017 survey shows that there was degradation of about 2 ft immediately adjacent to the bank, but that the thalweg became less defined and aggraded by 3 feet compared to the 2013 surveys. Degradation was observed on the right hand side of the channel from Sta 250 to Sta 600 (Figure 29). The section at the M&T intake (XS4) shows a similar trend between 2013 and 2017. There was aggradation in the thalweg near the pumps, and degradation of up to 3 feet between the thalweg and the right bank from Sta 225 to Sta 600 (Figure 30). At XS5, which is located slightly upstream of the M&T pump intakes, the 2017 survey shows slight aggradation (generally less than a foot) in the vicinity of the intakes; this is consistent with the dive survey observations. Degradation on the right side of the channel was less than in XS3 and XS4, but persisted from about Sta 350 to Sta 625 (Figure 31).

Figure 29. Comparative cross-section plots, 2005 to 2017 immediately downstream of the fish screens and pump inlets.

Figure 30. Comparative cross-section plots, 2005 to 2017 at the M&T/Llano Seco fish screens and pump inlets.

Figure 31. Comparative cross-section plots, 2005 to 2017 immediately upstream of the fish screens and pump inlets.

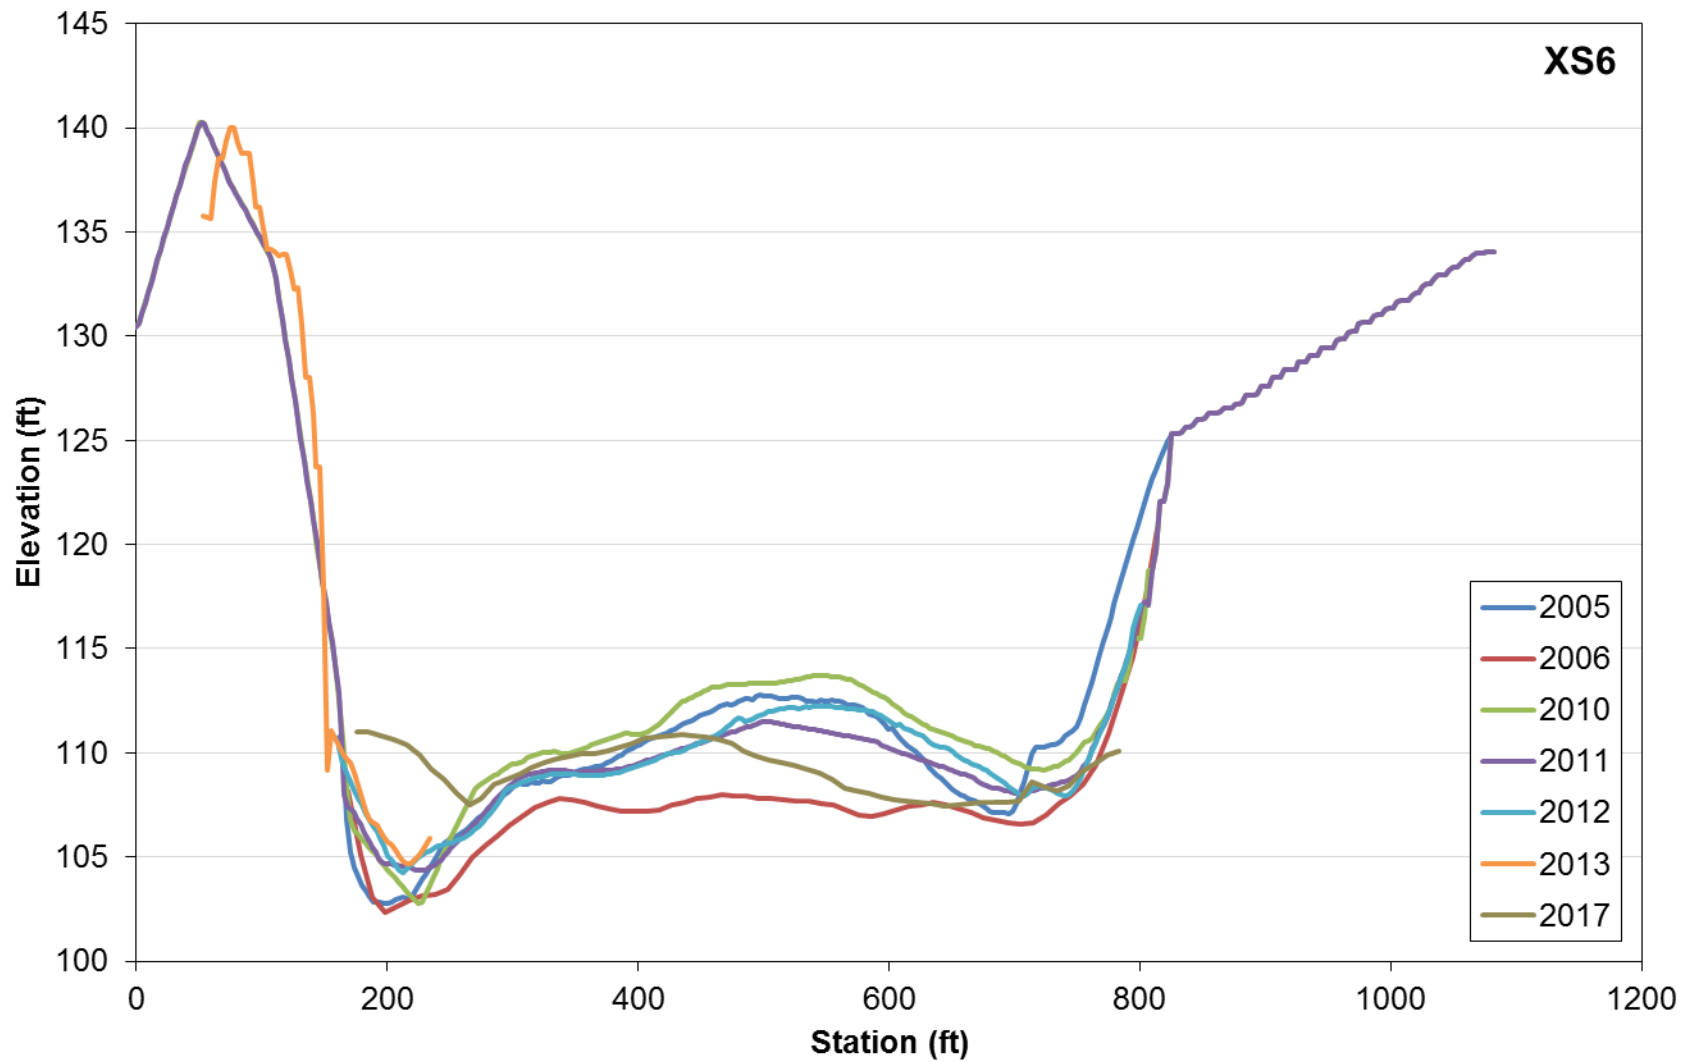
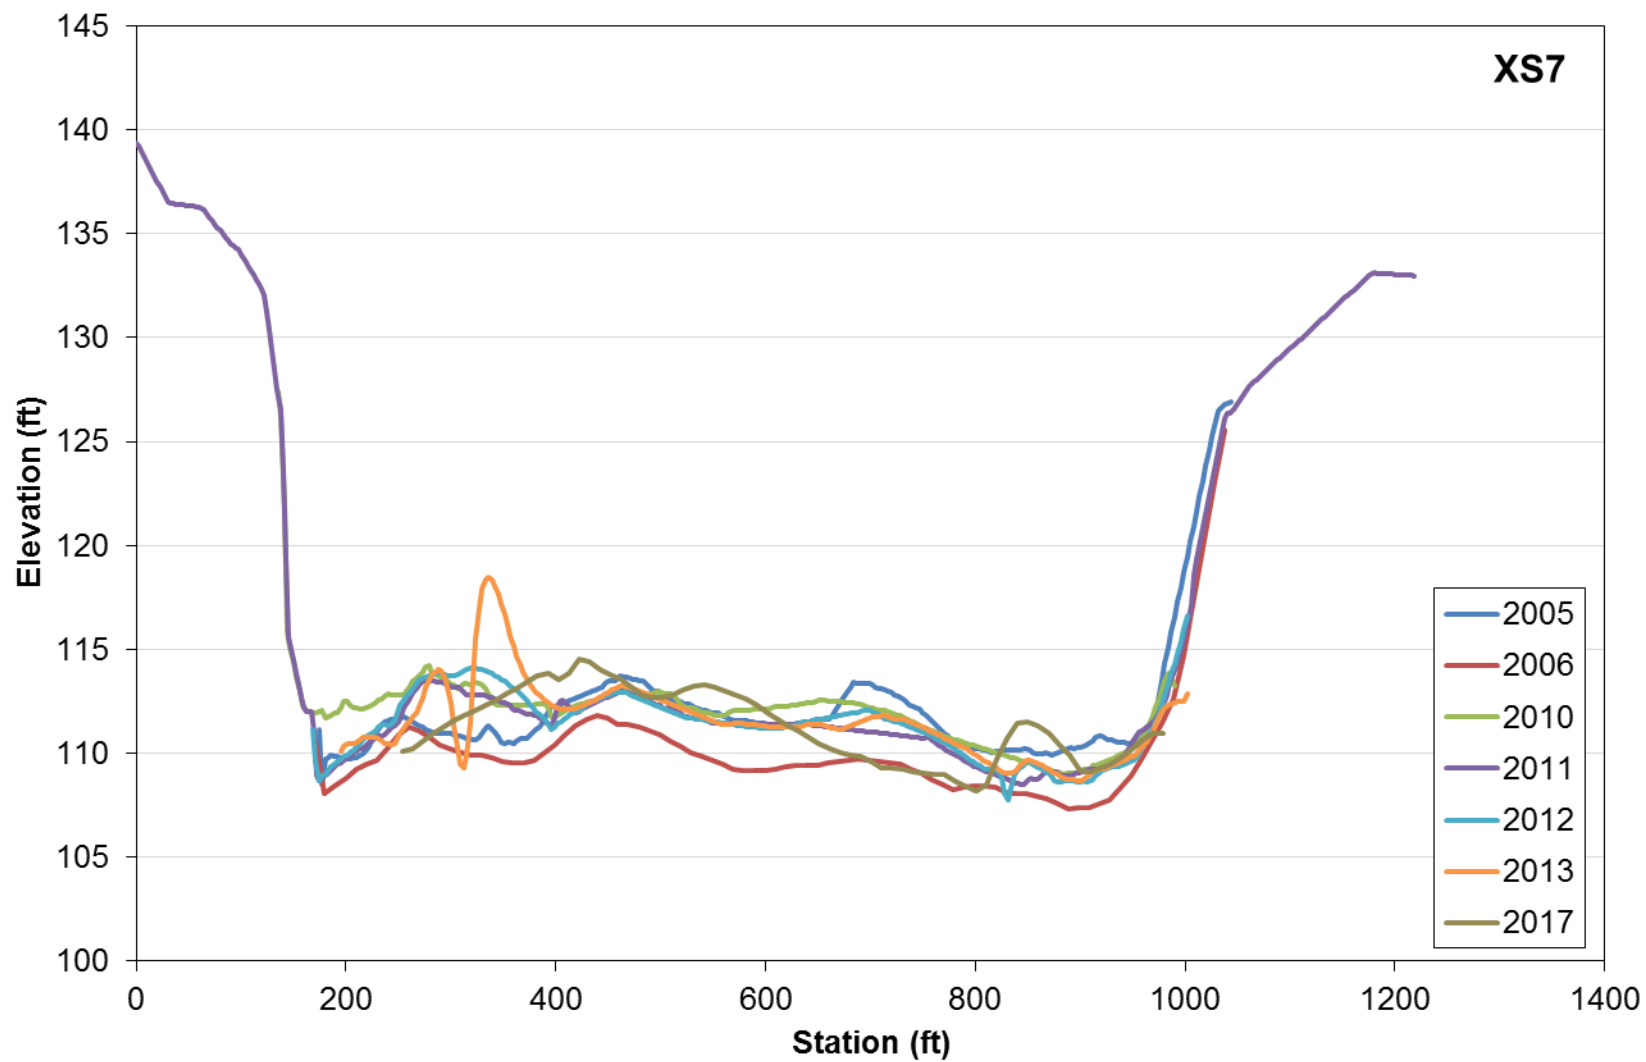
The same general trend is seen at the upper part of the migrating bar (**Figures 32 and 33**). Aggradation occurs during the lower peak flow years (2005, 2010, and 2012) and there is scour

in the higher peak flow years (2006 and 2011). The 2017 survey shows there was aggradation of up to 5 feet near the left bank of XS6 and localized differences (aggradation and degradation) of up to 5 feet in the main channel, but in general, between Sta 450 and the right bank, the 2017 survey shows degradation, trending towards a return to the 2006 geometry (Figure 32). At XS7, the 2017 bathymetry is similar to the 2013 data, alternating between aggradation and degradation across the channel, with deviations generally less than two feet (Figure 33).

Figure 32. Comparative cross-section plots, 2005 to 2017 upstream of the fish screens and pump inlets on the lower part of the migrating bar.

Figure 33. Comparative cross-section plots, 2005 to 2017 upstream of the fish screens and pump inlets on the upper part of the migrating bar.

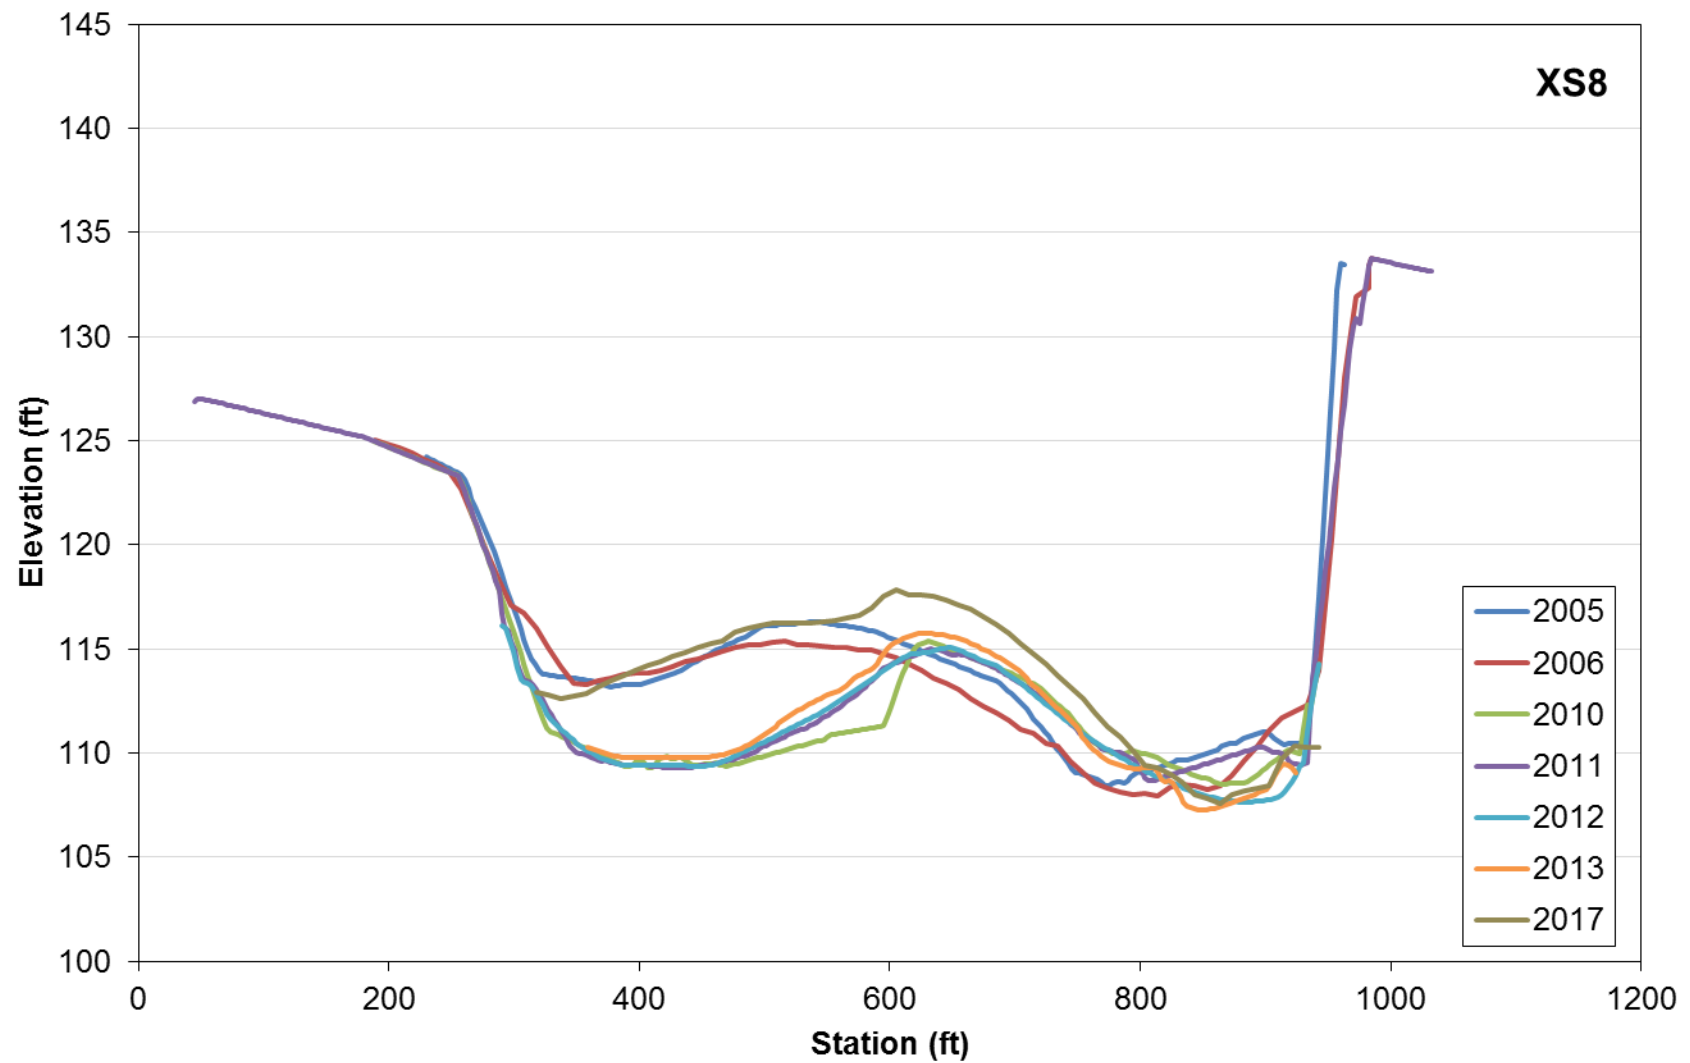
The comparative cross sections indicate that there has been significant aggradation in the left channel created by the gravel bar dredging. At XS8, the 2017 survey data show that the channel in this location has reverted to the pre-dredged geometry. The gravel bar itself may have aggraded by an additional three feet compared to the 2013 survey. The channel to the right of the gravel bar has remained stable since the 2013 survey. (**Figure 34**).

Figure 34. Comparative cross-section plots, 2005 to 2017 across the area that was dredged in 2007.

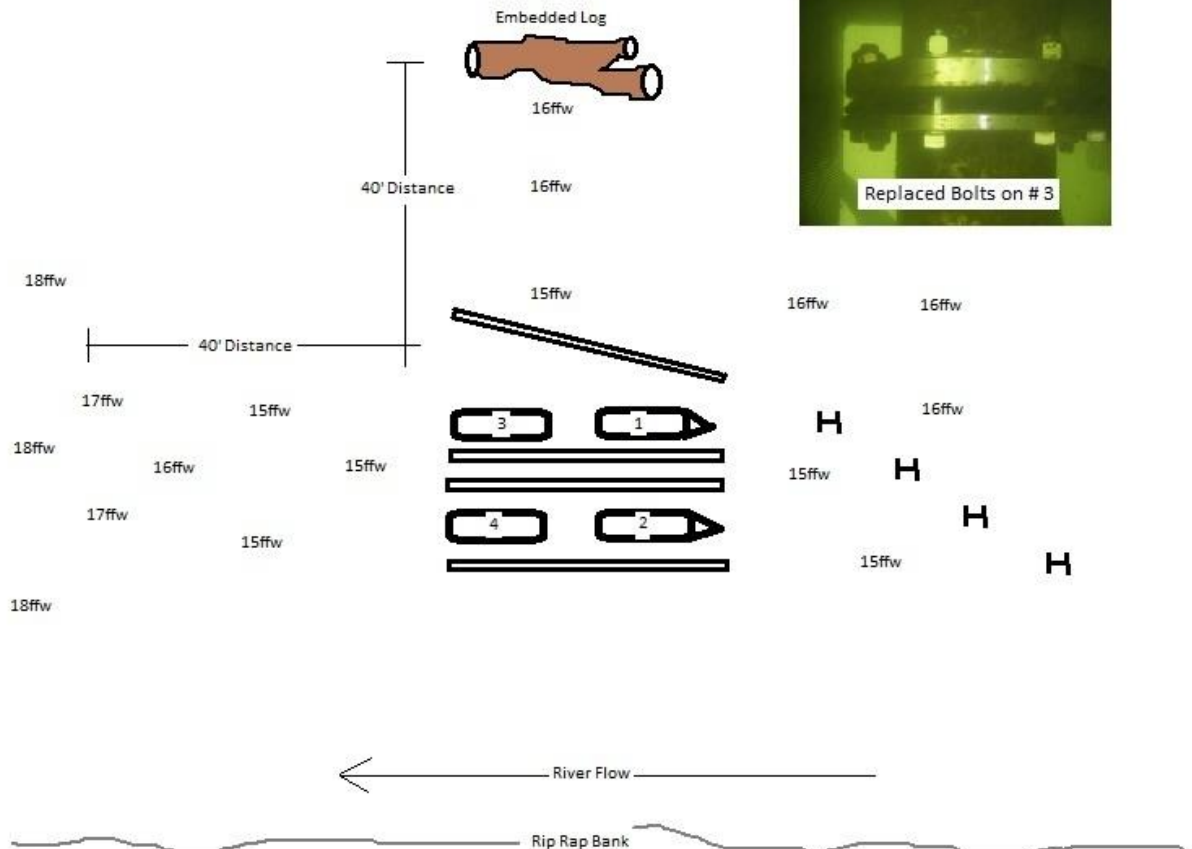
Ord Ferry 5-17-12 River Stage 97.75

Screen #1 - Flanges and bolts tight. Air test = No leaks. Screen cleaned. No dents.

6' from bottom of screen to sandy bottom.

Screen #2 - Flanges and bolts tight. Air test = No leaks. Screen cleaned. No dents.

5' From bottom of screen to sandy bottom.

Screen #3 - Flanges and bolts checked. 2 Galled Stainless Steel bolts found. Bolts removed and replaced.

Bolts tightened. Air test = Small leak at beginning of air burst. Determined leak is workable and not to be repaired but will monitor. Screen cleaned. Two dents found. Diver able to rebend wedge wire back to operational status and closed up small gap. 4' From bottom of screen to sandy bottom.

Screen #4 - Flanges and bolts tight. Air test = No leaks. Screen cleaned. No dents.

3' From bottom of screens to sandy bottom.

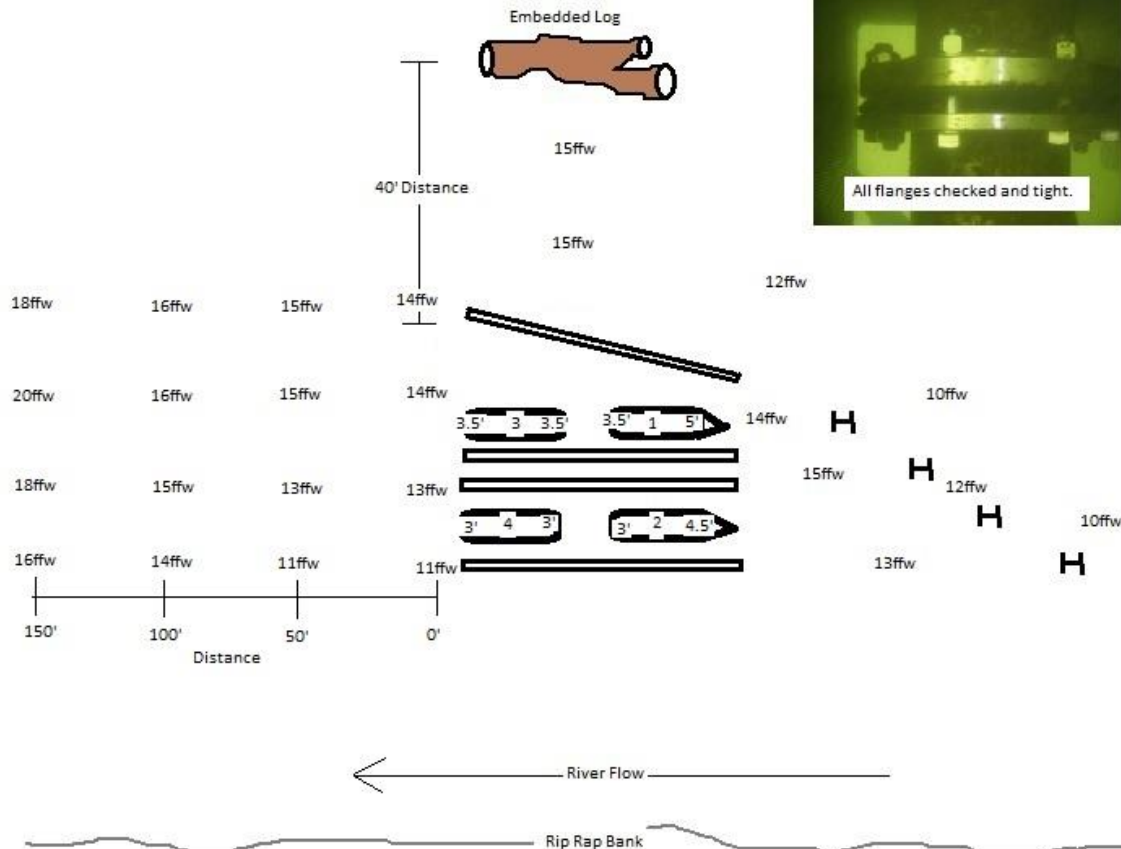
Ord Ferry 3-20-13 River Stage 97.1

- Screen #1 - Flanges and bolts tight. Small dent, no gap. Screen cleaned.  
4.25' Average under screen to sand and gravel bottom.
- Screen #2 - Flanges and bolts tight. No Damage. Screen cleaned.  
3.75' Average under screen to sand and silt bottom.
- Screen #3 - Flanges and bolts tight. Small dent, no gap. Screen cleaned.  
3.5' Average under screen to sand and gravel bottom.
- Screen #4 - Flanges and bolts tight. No Damage. Screen cleaned.  
3' Average under screen to sand and silt bottom.

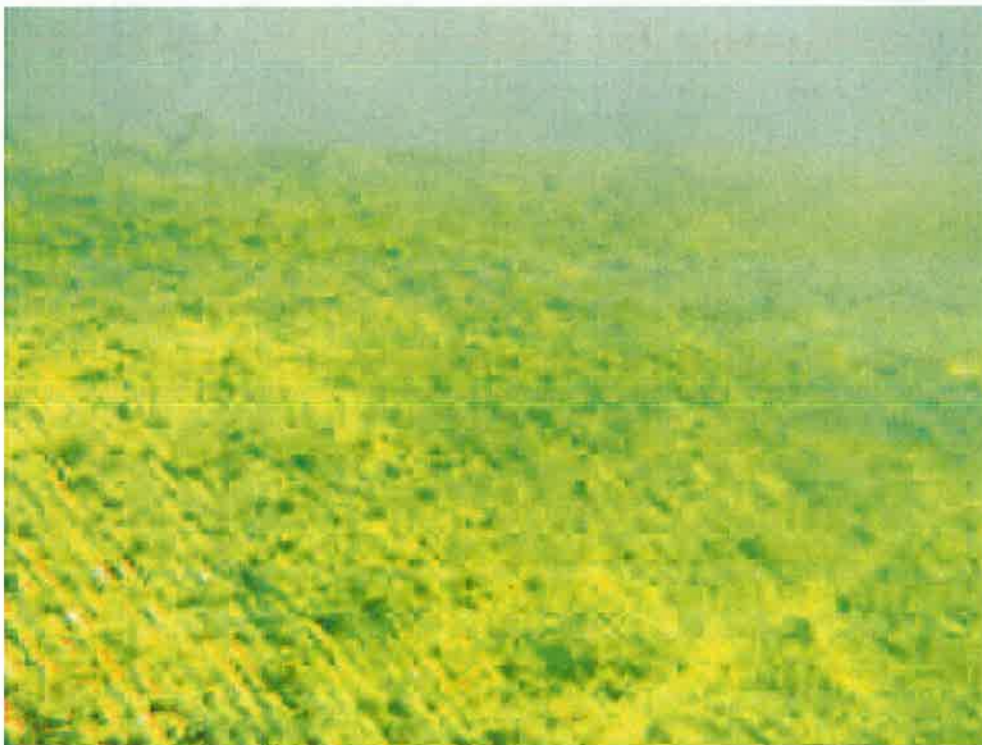
Divers surveyed all surfaces of the screens and explored the vicinity upstream and outboard into the river. The upper surfaces of all screen cylinders were covered with algae (Figure 3). Divers did not observe any damage to the screens even though it is known that there was a depression in the top of one cylinder at the prior inspection in 2011 and personnel with M&T Ranch said the indentation had not been fixed. The indentation is slight and must have been camouflaged due to the algae growth.

**Figure 3. Algae on all upper surfaces of screen cylinders. The amount of algae observed is typical for a shallow screen on the Sacramento River and will not appreciably restrict water flow.**

The screens are in good shape. The amount of algae seen on upper surfaces is typical and not an issue if cleaned once or twice a year by professional divers. There was no evidence of a gravel bar moving towards the screens, although the scope of this inspection was limited in proximity to the screens. The air burst cleaning system appeared to be strong enough to keep light sediment clear of the bottoms of screen units, providing sufficient clearance between the screens and the substrate. The facility would benefit from having stronger currents to move leafy debris away from the screens after initiating a cleaning cycle. Since the screens are in an eddy at the existing river flow, the light sediment will continue to accumulate in that area. Flow patterns may change at higher flows to remove the light sediment and perhaps the light woody debris.

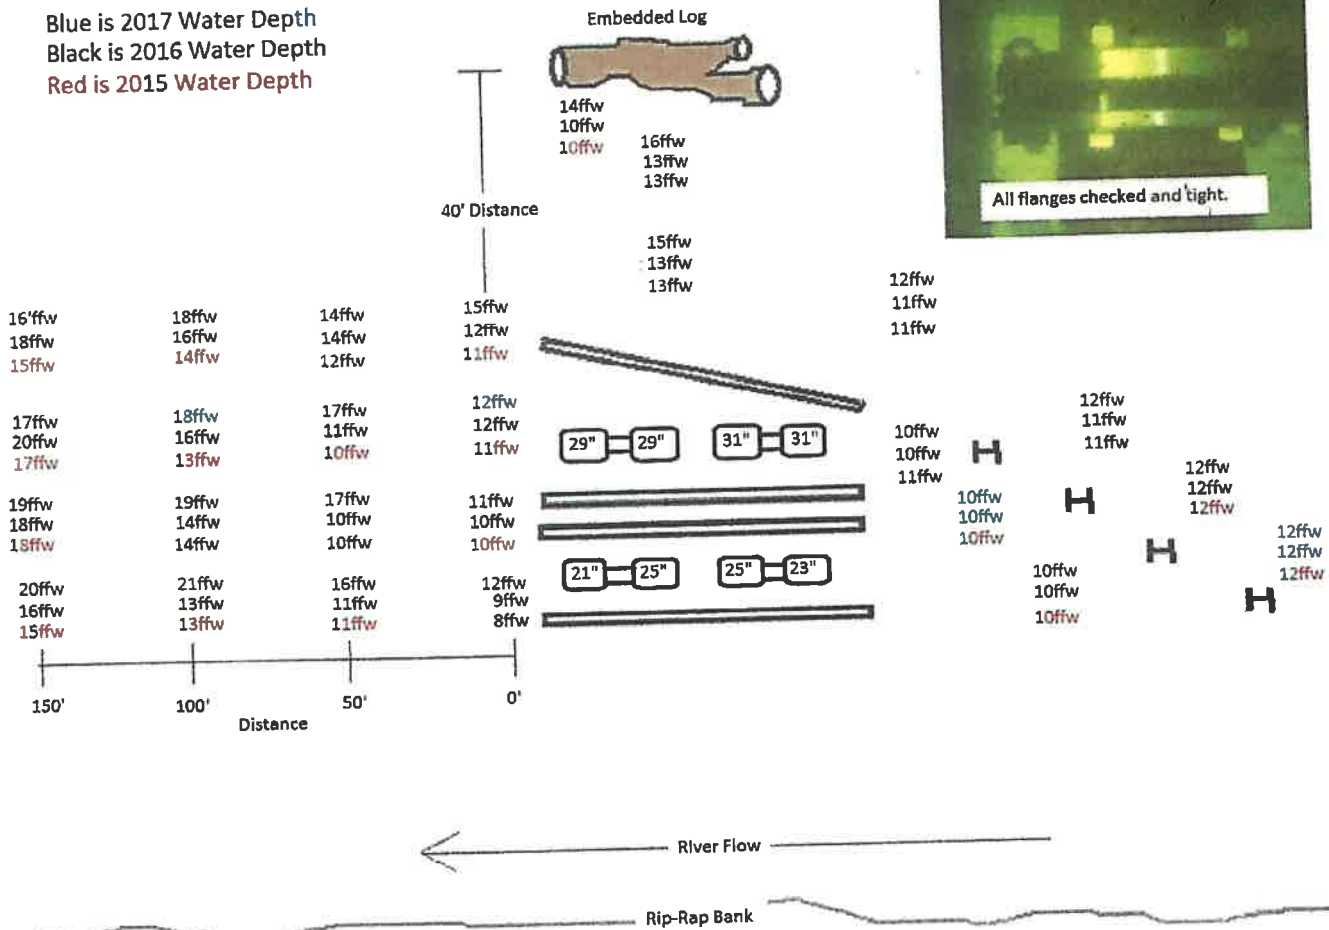
- Screen # 1: Flanges and bolts tight. Small dent with no gaps. Screens Cleaned. 31" Average under screen to sand and gravel bottom.
- Screen # 2: Flanges and bolts tight. No Damage. Screens Cleaned. 24" Average under screen to sand and silt bottom.
- Screen # 3: Flanges and bolts tight. Small dent with no gaps. Screens Cleaned. 29" Average under screen to sand and gravel bottom.
- Screen # 4: Flanges and bolts tight. No Damage. Screens Cleaned. 23" Average under screen to sand and silt bottom.
