TO: Jim Well, Ducks Unlimited  
FROM: Dai Thomas, PhD., PE, and Mike Harvey, PhD., PG  
SUBJECT: **June 2017 Resurvey of M&T/Llano Seco Pumping Plant and City of Chico Outfall Reach of the Sacramento River  
M&T/Llano Seco Fish Screen Facility Long-term Protection Project, Phase IV, Project No. US-CA-62-6**  
DATE: July 26, 2017

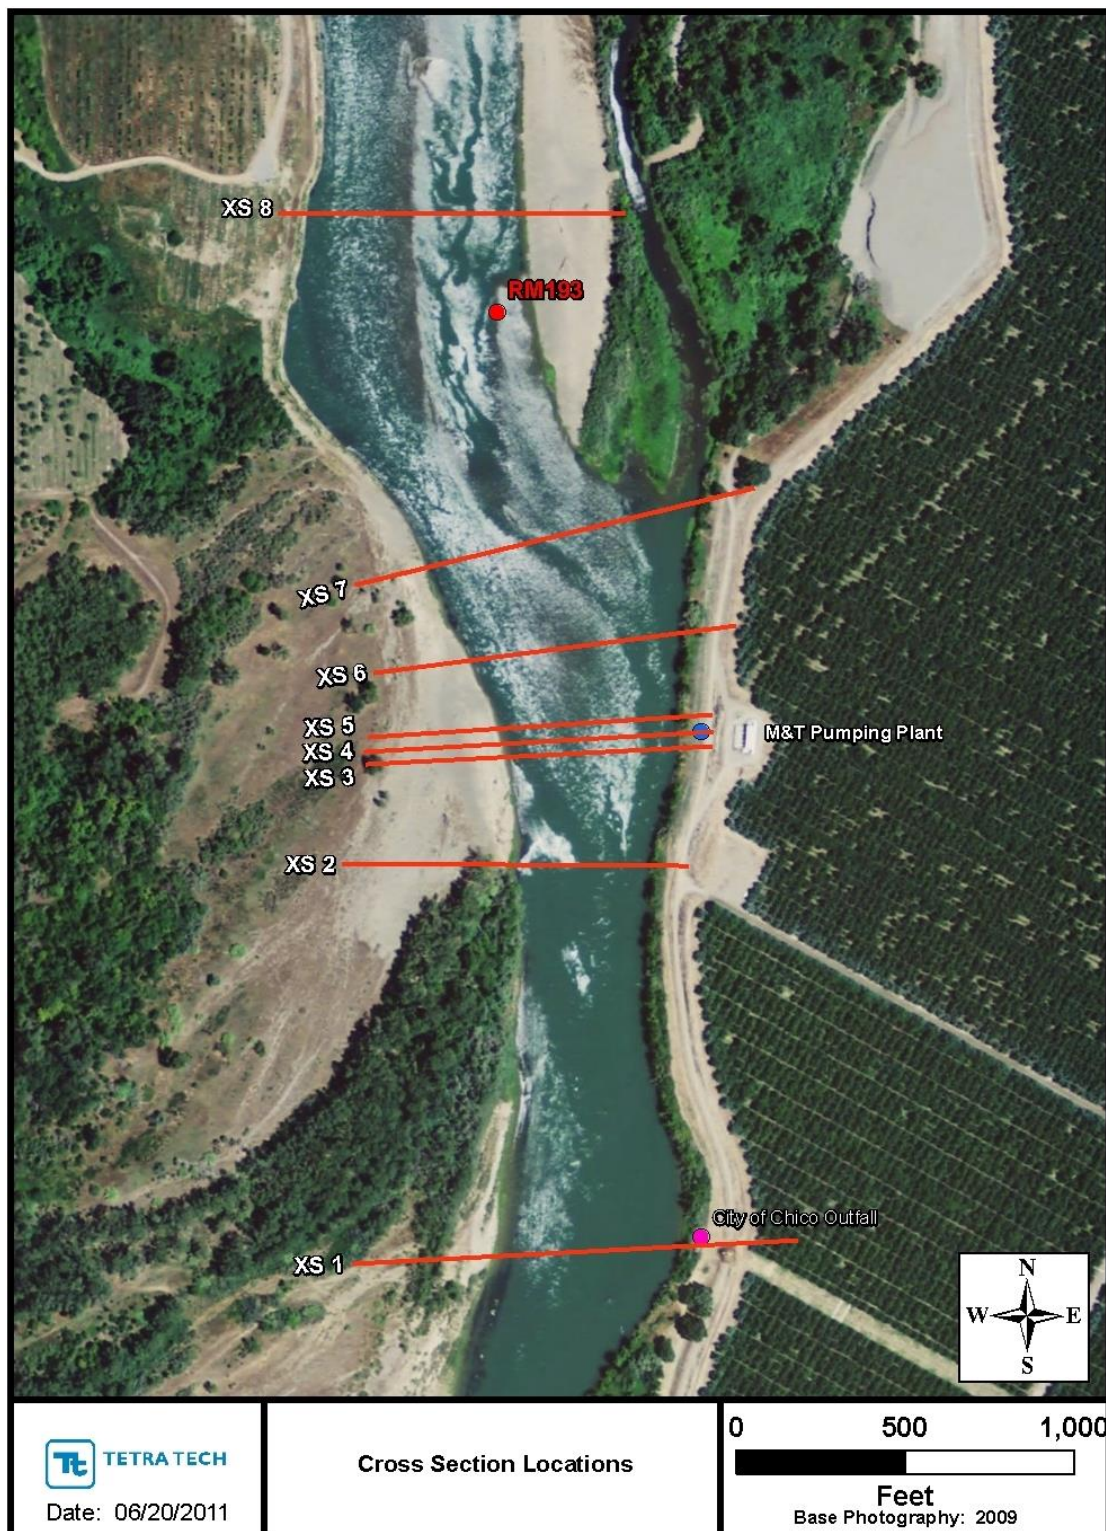
The peak flow between the 2012 and 2013 surveys was about 85,600 cfs, which is slightly less than the bankfull discharge of 90,000 cfs, and the duration of the peak flow event was less than one day. Between 2012 and 2013, there was a relatively small amount of deposition in the vicinity of the fish screens and pump inlets, but the general pattern of deposition at less than bankfull discharges was observed (Figure 17 and **Figure 24**). Between 2013 and 2017, peak flows exceeded the bankfull discharge on several occasions, but in general the period was relatively dry. There was slight degradation along and near the thalweg, and aggradation along the left bank of the channel and in the vicinity of the fish screens (Figure 19 and **Figure 25**).

Figure 25. Color gradient plot showing the bed topography in the vicinity of the M&T/Llano Seco Pumping Plant and the relocated City of Chico Outfall in June 2017.

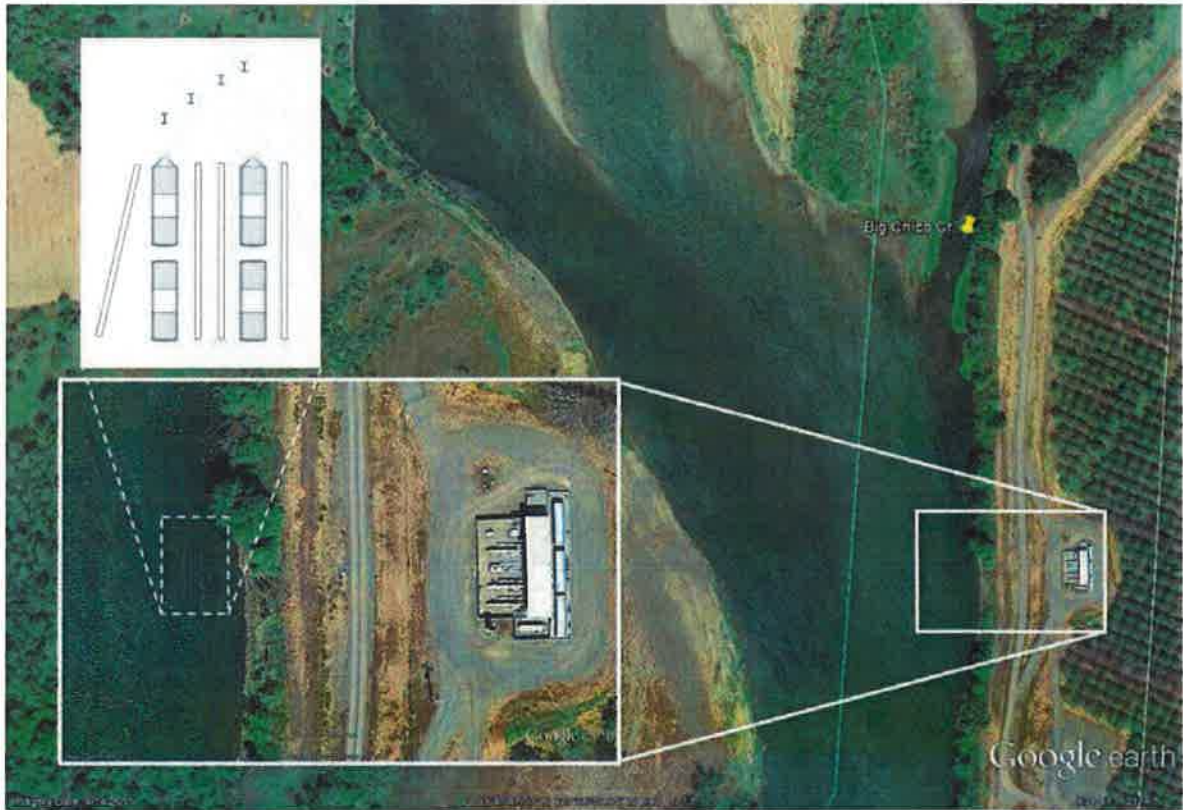
The diversion is located on river-left of the Sacramento River at about river mile 193. The pumping plant is located on the land side of the levee as shown in Figure 1 and has a capacity of 150 cfs. The intake is approximately 500 feet downstream from the confluence of Big Chico Creek and the Sacramento River.

**Figure 1. Location of the pumping plant and fish screen. Inset shows a plan view sketch of the screens and protective elements. The intake is on the Sacramento River immediately downstream from the confluence of Big Chico Creek. Stream flow is from top to bottom in the photos.**
